Access and Discovery Trails

Rush Creek Fire Road
Bugeia Lane, Novato

Inclusive Access Plan
Access and Discovery Trails

Rush Creek Fire Road

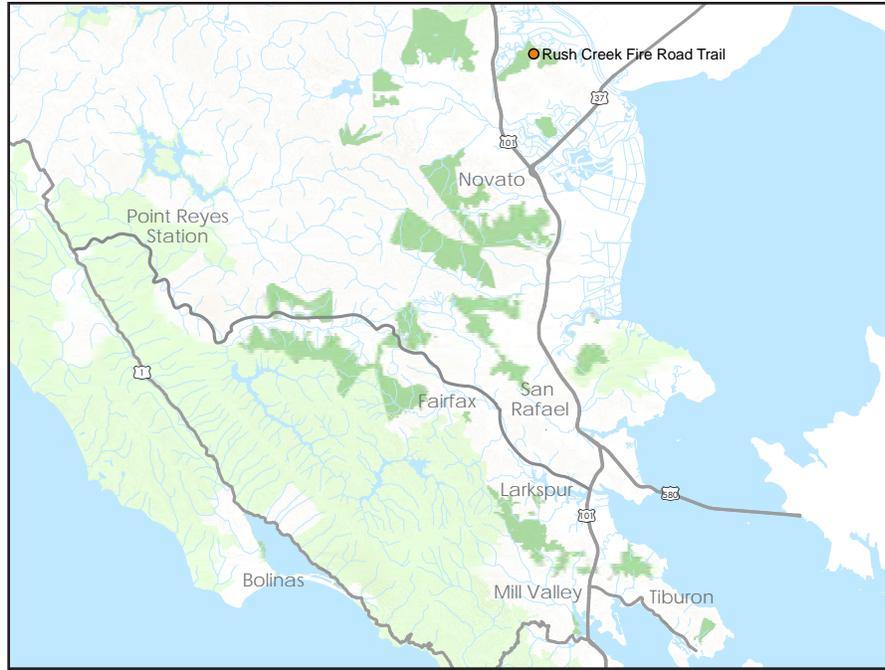
Bugeia Lane: The pedestrian access opening adjacent to the vehicle gate is 44-¾ inches wide and has a 3.3% running slope. The fire road connecting to the trail is 8 to 10 feet wide and is surfaced with a compacted base with some loose surface gravel. The fire road/trail has a slight crown creating up to a 4% cross slope at edges. Sections of the trail have loose sand material up to ¾ inch deep.

Much of the fire road has a clear width of greater than 8 feet. Grass medians occur at several sections along the length of the trail and reduce the clear trail width. Parallel social trails on the uphill side of the trail are present where poor drainage result in wet trail conditions.

At the incline from the Cemetery Marsh section to the Basalt Creek section, an erosion channel was noted on uphill/inside curve of road.

The trail surface is varied with sections of compacted sandy/silty clay considered to be firm and stable in its dry state, larger loose road gravel, and loose fine sand. Areas were observed with a top layer of sand at a depth of 1 inch. Segments of the trail along Cemetery Marsh are rutted and have standing water following rains. Further drainage issues are evident where horse and bicycle tracks were observed in hardened dry surfaces. Cross slopes were less than 5%. Two sections, both where the trail is facing the Petaluma River Marsh Wildlife Area, had cross slopes of 12% and 17%. Running slopes along much of the trail are less than 5% with a few sections up to 12.5% where the road turns to run along the Basalt Creek.

The trail has poor drainage with evidence of standing water. There is a possibility of seasonal closures during high water periods. An assessment of the existing trail surface materials suitability to be properly compacted to meet access requirement may be needed. Existing wood boards on the bridge surface have gaps that exceed the allowable ½" gap. Replacement of the boards with properly spacing is recommended.

Proposed Improvement: Provide an accessible parking area with a single accessible stall including access aisle at the Bugeia entrance and two paved parking spaces not designated for accessibility. Grading and construction of retaining wall will be required to create a level parking area.

Proposed Improvement: Provide an accessible surface connecting the accessible parking space and the trail/fire road.

Proposed Improvement: Remove sections of loose surface materials and replace with firm and stable compacted surfacing. Install edge protection at the steep slope immediately south of the pedestrian bridges. Modify the trail section between the bridges to provide a more level connection. Provide resting intervals at several locations where the trail has steeper sections. Consider providing a resting place with a bench at a shady spot along the trail alignment.

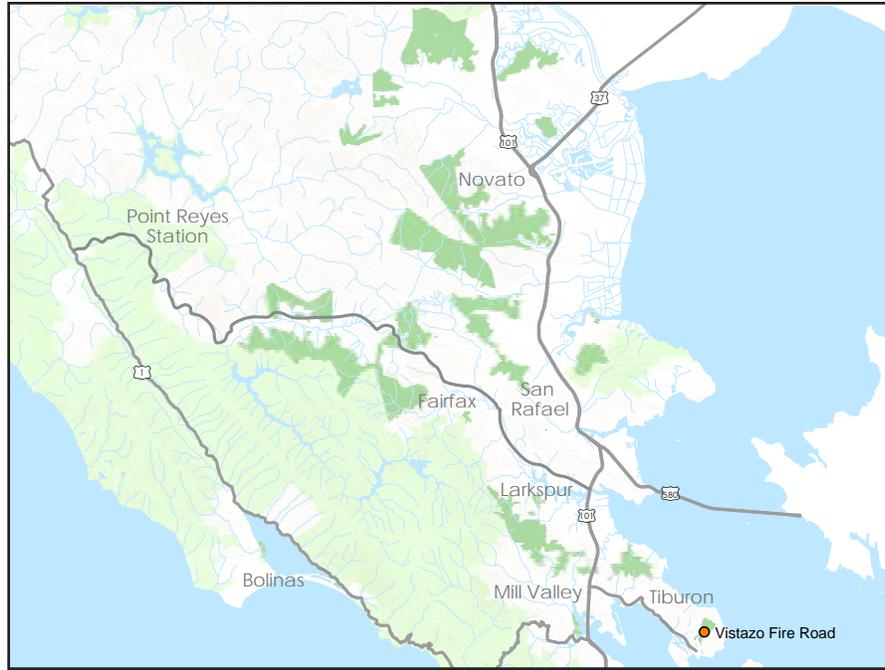
A small, informal parking area at the trailhead to the north could provide parking for about 4 vehicles. The surface is loose gravel and dirt with 15% to 20% running slopes and 1% to 3% cross slopes. Informal street parking within the right-of-way exists at the southern end of the alignment with 2% to 4% slopes in either direction.

The trailhead at either end has a normally closed vehicular gate with a 36 inch wide pedestrian entry.

The trail is comprised of a combination of imported road base and compacted native serpentine soil and varies in width from 10 to 20 feet. Short sections of trail have severe erosion, exposed bedrock, and larger rocks. An perennial stream crossing exists which narrows the trail to approximately 6 feet. Most of the trail has running slopes of less than 10% and cross slopes less than 5%. A short segment immediately south of the stream crossing has a 20% running slope. Drainage from the adjacent hill side has cut deep ruts into sections of the trail surface.

Regrading the entire width of the fire road may have undesired environmental impacts on the serpentine soils and associated plant communities. Modifying the existing drainage patterns may be advisable to reduce future trail surface erosion.

Proposed Improvement: Consider installing a blue curb and signage at the southern end of the trail at the cul-de-sac. The specific location of the blue curb and pole mounted sign is to be determined to minimize visual impact from the adjacent property.

Proposed Improvement: Minor regrading/surfacing improvements at the entry pathways at both ends of the trail. Any work required must be done within the existing road tread to avoid impacts to sensitive natural resources.

Proposed Improvement: Due to pragmatic implications of the effort necessary to improve and maintain the current road bed, surface improvements to the trail alignment will be limited to the first 300 linear feet of fire road from the south entrance. The remainder of the fire road will be treated as an Improved Access Trail with expanded conditions information being made available. The County will explore additional environmental improvements to the trail alignment.

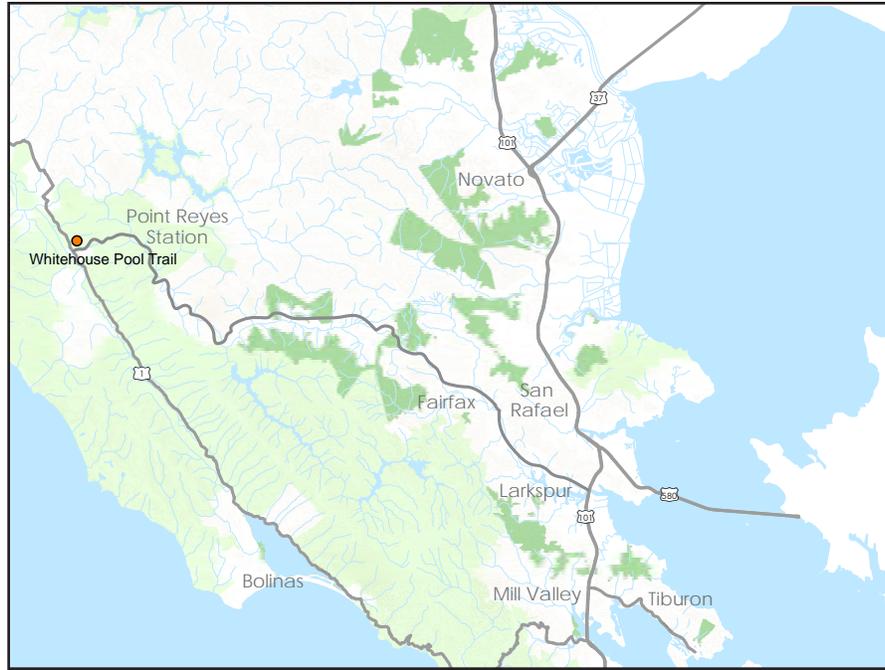
A paved parking area is provided at the trailhead. The asphalt parking area is not striped and does not include designated accessible parking spaces.

The entrance to the trail has a removable bollard with an opening 53 inches on one side and 54 inches on the other side. The entrance is level but the surface at the transition from asphalt paving to the trail is loose gravel.

The trail varies from 12 to 36 inches wide. Many sections of the trail have overgrown vegetation both on the ground surface and overhead reducing the clear width and height.

The trail has two timber bridges. The bridge adjacent to Sir Francis Drake Blvd on the east side of the site is 60 inches wide. A 14% slope and 3 inch change in level were observed at the transition plate. The second bridge crossing the inlet between the two trail sections is 48 inches wide. The wood transition on the east side of the bridge has a slope of 12% for 14 linear feet and up to 24 inch changes in level on either side with no edge protection. The transition on the west side includes a 14 foot long timber section with a slope up to 6% connected to an earthen ramp with a slope of 9% to 11% for 15 linear feet.

The trail surface is varied with compacted native surface that is firm and stable in its dry state. Sections were observed with a top layer of loose small gravel.

The trail surface is irregular in some sections, with surfaces not considered firm and stable. Seasonal rains and high water may be a maintenance issue. The site is known to flood seasonally, making sections of the trail impassable at certain times of year.

Proposed Improvement: Regrade a portion of the parking lot closest to the trail head adding markings, striping, signage and an access aisle. Install wheel stops to create an accessible 48" min. wide path to the existing portable toilets.

Proposed Improvement: Provide a section of stabilized decomposed granite or similar firm and stable surface at the pavements/trail transition to prevent vertical changes in elevation caused by erosion and wear.

Proposed Improvement: Improvements to the pedestrian bridge near the parking area include modifying the slope of the approach ramp, installing safety railing to the wooden bridge ramp. Trail improvements include widening the trail tread and providing accessible trail surfacing to selected benches at the bank of the creek. A section of boardwalk is also recommended to address reduced trail width along the riparian clearing as noted on the diagram.

Proposed Response: Temporary closures of sections of the trail affected by flooding may be necessary. Ensure information is updated and available to convey current conditions of the trail. Ensure firmness and stability of trail surface is evaluated and addressed after water recedes.
