# **Bolinas Lagoon Ecosystem Restoration Feasibility Project**

### **IV Conceptual Littoral Sediment Budget**

**DATE:** July 11, 2005  
**TO:** Al Paniccia  
**COMPANY:** USACE  
**FROM:** Don Danmeier and Philip Williams  
**COPY TO:** Bill Carmen  
**RE:** Conceptual Littoral Sediment Budget at Bolinas Inlet  
**PWA Ref. #:** 1686.03

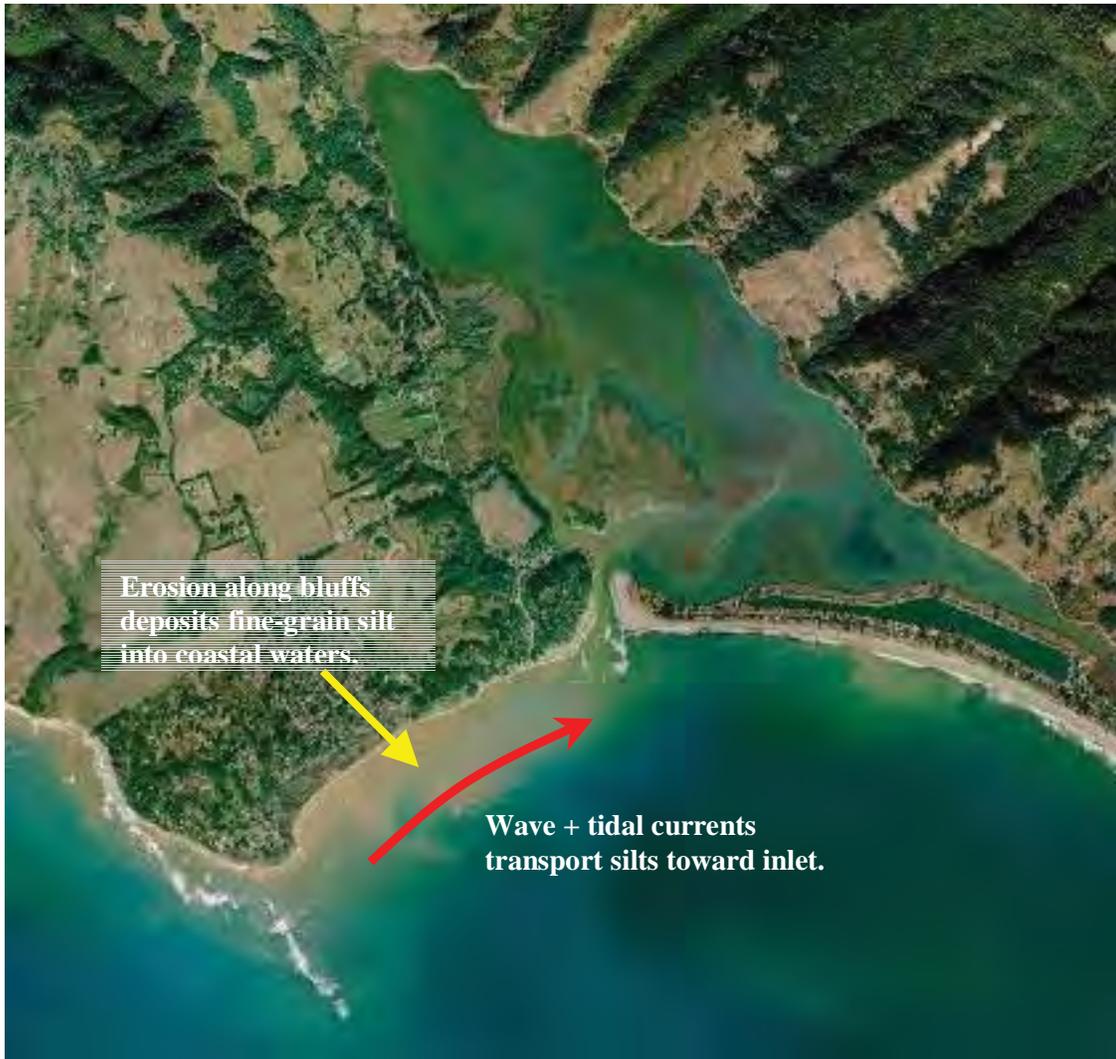
*figure 3*  
*Conceptual Littoral Sediment Budget at Bolinas Inlet*

**Erosion and Transport at Bolinas Bluffs**

1. Bluff erosion along Bolinas. Wave attack along the bluffs west of Bolinas delivers sediment to the littoral zone that is subsequently transported toward the inlet by wave and tidal currents (Figure 3). These bluffs, which are primarily composed of erodible Monterey Shale, are receding at a rate of about 1.5 ft/yr, resulting in approximately 1 million cubic feet (mcf) per yr (or about 37,000 cubic yards per year (CY/yr) of sediment introduced to the littoral zone (Ritter, 1973). Wave action and currents sort the sediment deposited at the base of the bluffs, leaving coarse-grain sands along the beaches and transporting a portion of the eroded material toward Bolinas Lagoon and a portion into deeper water in Bolinas Bay.

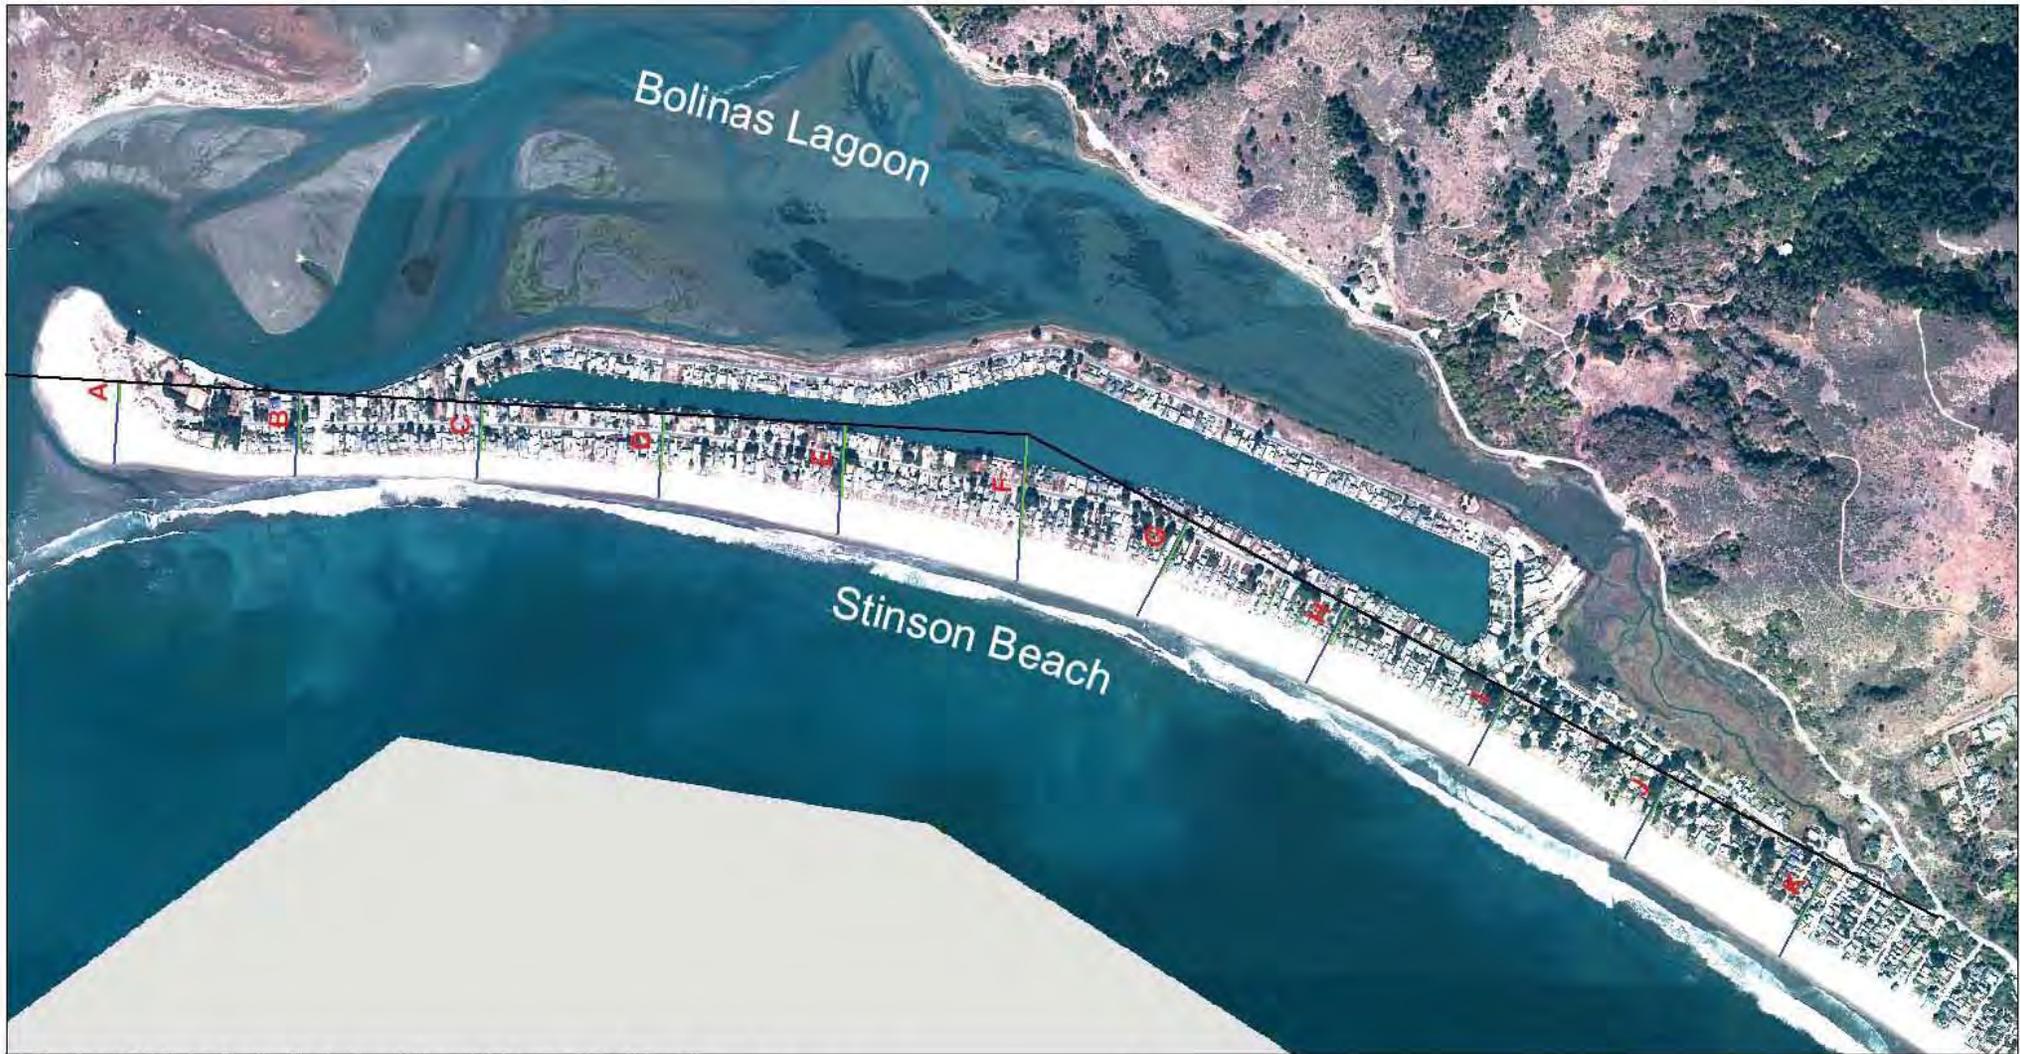
figure 5

Note: Beach Width is defined as the distance between the Average High Water Line and the Vegetation Line

Conceptual Littoral Sediment Budget at Bolinas Inlet  
**Shoreline Analysis- Transect Configuration**

In order to quantify beach dynamics, PWA staff reviewed eleven aerial photographs collected from 1942 to 2001 using GIS tools. PWA staff digitized the average high water line for each photograph by examining differences in reflectance and micro-topography such as wind-rippled sand. Beach width was then computed as the distance from the average high water line to the vegetation line for the 10 transects shown in Figure 5<sup>1</sup>. Beach widths measured at each transect are plotted in Figure 6, while Figure 7 shows the average, minimum and maximum beach width measured along the beach for each photograph. As demonstrated by these results, most of the variance in beach width is within the typical seasonal variability reported by others (Johnson, 1973) or occurred after strong El Nino winters. Beach recovery appears to be complete, even after intense El Nino years. Overall, these results do not reveal any long-term trend in beach width that can be attributed to armoring of the Seadrift, suggesting that most of the eroded sand is temporarily stored in offshore bars and later transported back onto the beach.

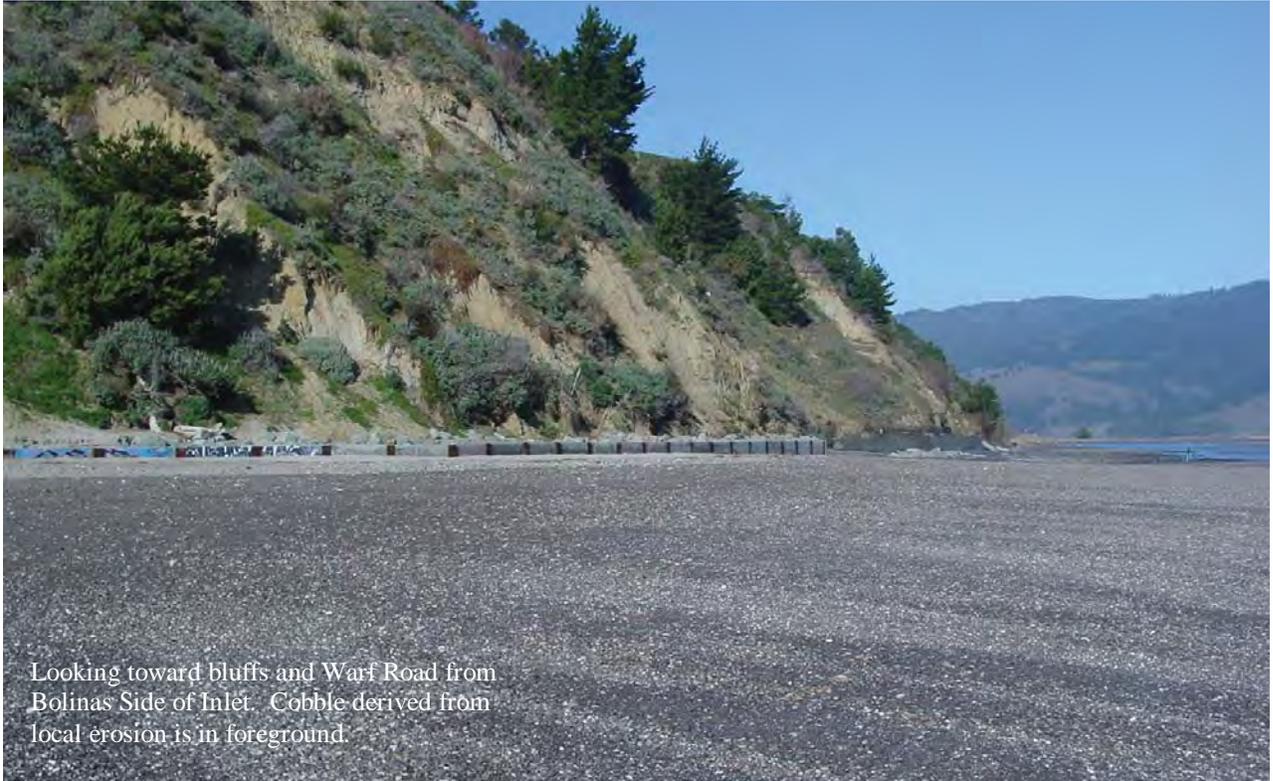
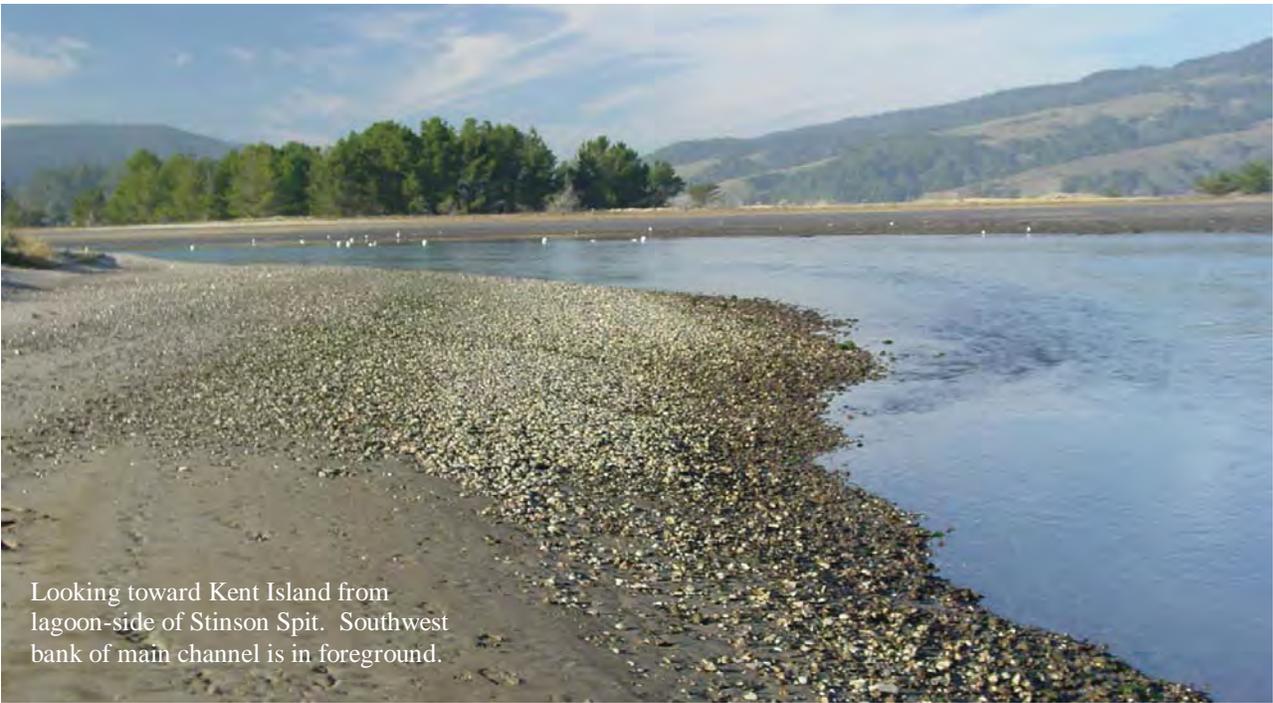
*figure 8*  
*Conceptual Littoral Sediment Budget at Bolinas Inlet*

Looking toward bluffs and Warf Road from Bolinas Side of Inlet. Cobble derived from local erosion is in foreground.

Looking toward Kent Island from lagoon-side of Stinson Spit. Southwest bank of main channel is in foreground.

**Cobble Sediment at Inlet**

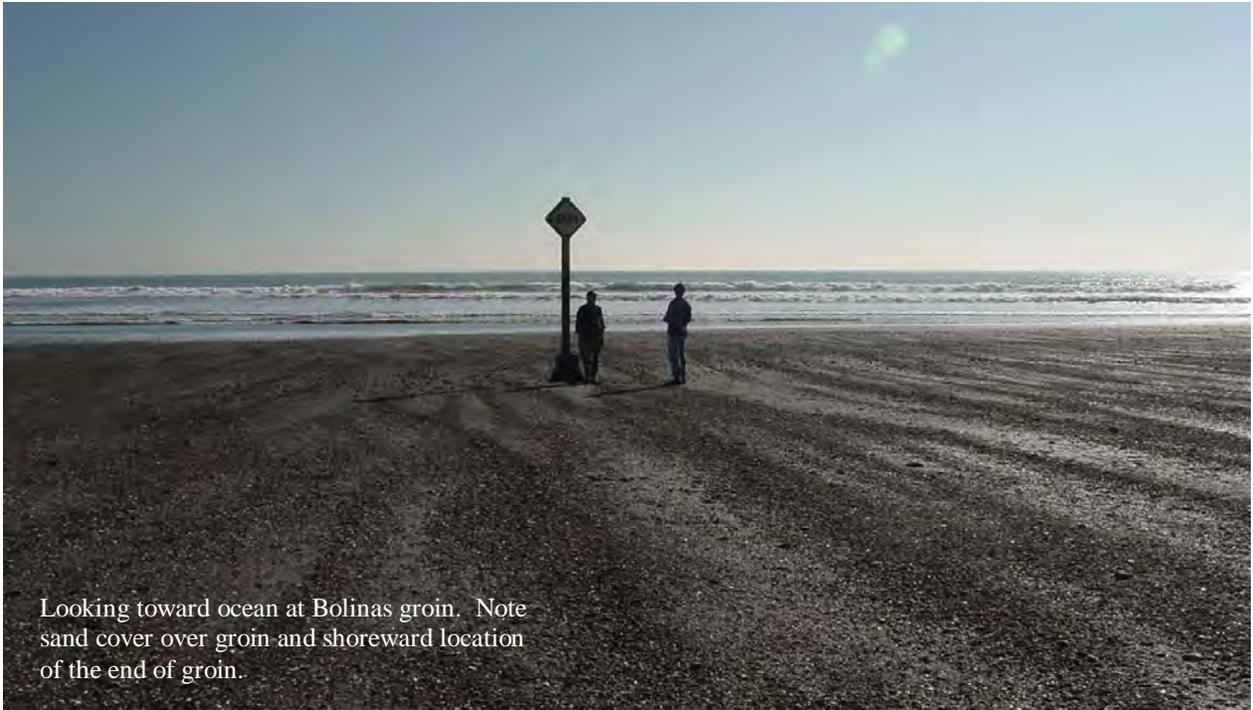
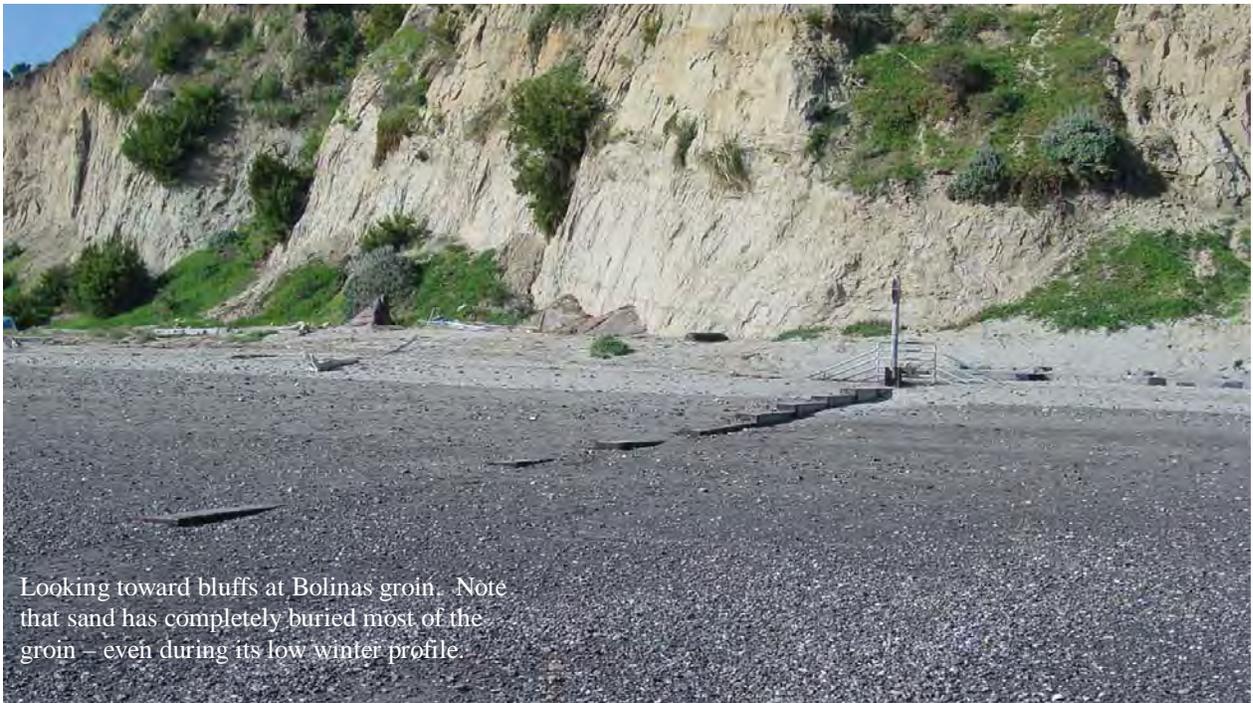
*figure 9*  
*Conceptual Littoral Sediment Budget at Bolinas Inlet*

Looking toward ocean at Bolinas groin. Note sand cover over groin and shoreward location of the end of groin.

Looking toward bluffs at Bolinas groin. Note that sand has completely buried most of the groin – even during its low winter profile.

**Bolinas Groin Buried by Sand**

- A properly functioning Bolinas groin partially traps longshore drift directed toward the inlet and is effective at increasing the size of Brighton Beach. However, the effects of the groin on coastal processes are limited due to its relatively low elevation and short length. Wave breaking around the tip of the groin and inundation at high tide demonstrate that sand bypasses the structure once the beach builds-up to its equilibrium size.

The effects of the Bolinas groin on longshore transport is evident from historical observations; from the late 1880's to the present day, the presence of an intact structure has been increasing the size of Brighton Beach effectively by impounding sand moving toward the inlet. The relatively short length and low elevation of the groin limit the effects of the structure, with sand bypassing the structure once the beach builds up to its equilibrium profile (Figure 9). Assuming a beach length and width of 600 ft and 240 ft, respectively, and 7 ft of vertical accumulation, the groin traps approximately 1 mcf of sand. The localized trapping of sand probably has a limited influence on the pattern of sand transport near the inlet by deflecting the longshore drift slightly offshore, with probable negligible effects on littoral sediment inflows to the lagoon.

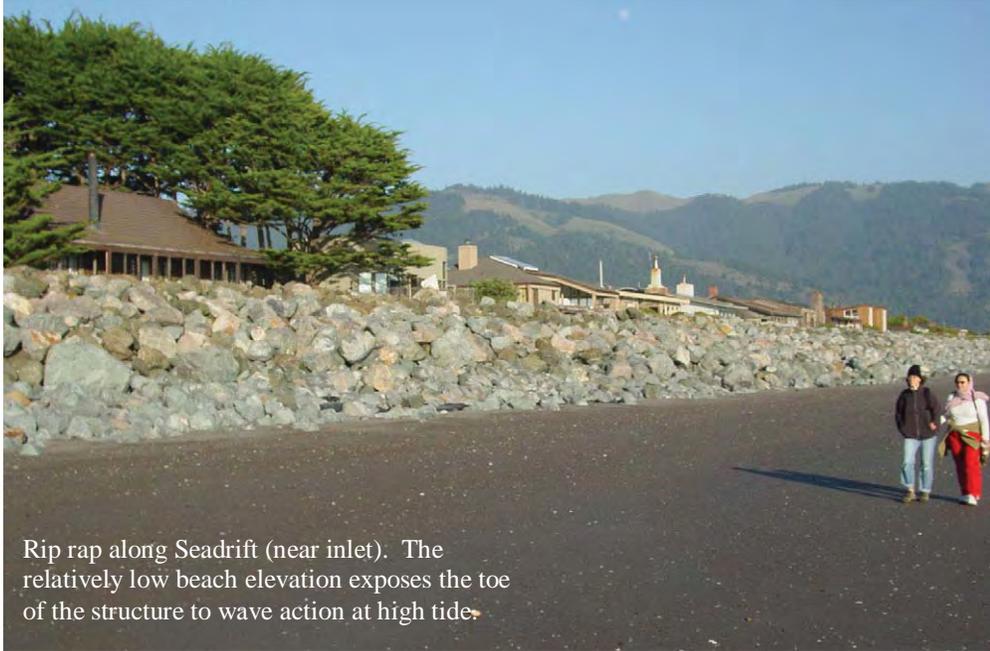
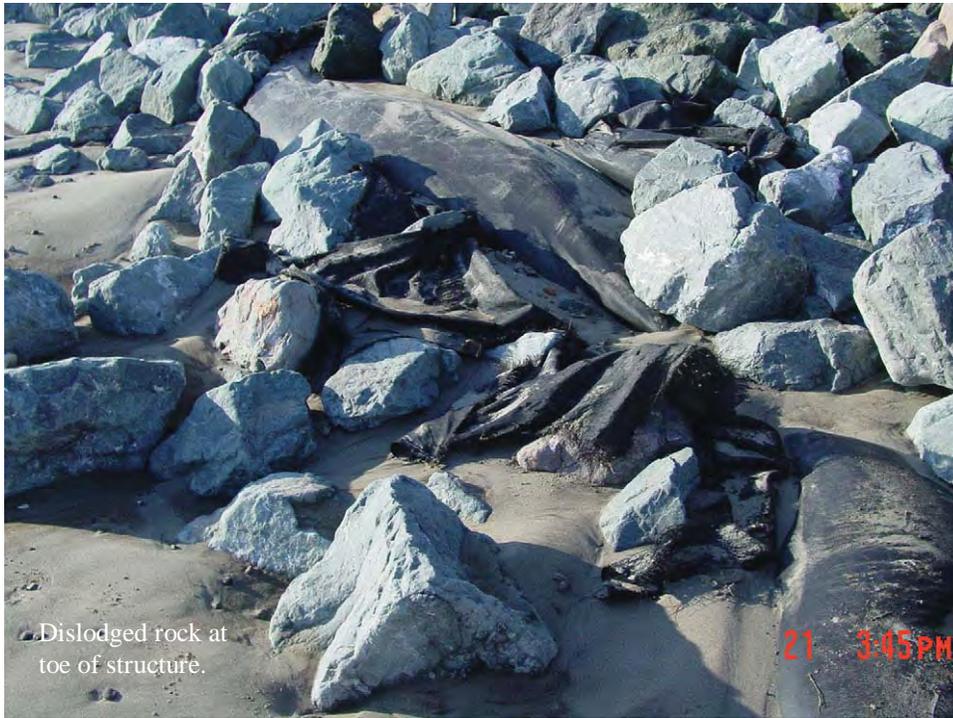
*figure 10*  
*Conceptual Littoral Sediment Budget at Bolinas Inlet*

Rip rap along Seadrift (near inlet). The relatively low beach elevation exposes the toe of the structure to wave action at high tide.

Dislodged rock at toe of structure.

**Dislodged Rock at Rip Rap**

- Waves reflected from riprap along Seadrift Beach focus wave power along the nearshore and have the potential to lower the equilibrium beach profile. A lower beach elevation increases wave attack on the structure, especially at its toe where PWA staff observed dislodged rocks during a field visit in January 2004. Although a mechanism for reducing longshore transport has been identified (i.e., lowering of the beach by wave focusing), data reviewed by PWA do not reveal any change in beach morphology due to installation of the riprap, and its effects on existing rates of longshore transport are expected to be minor.

The original revetment was constructed using stone 2 to 3 ft in diameter ( $\frac{1}{2}$  to  $1\frac{1}{2}$  tons in weight) and placed at a 2.5:1 (horizontal:vertical) slope, with a crest elevation of +17.5 ft MLLW and a toe elevation of approximately +7 ft MLLW. A 1998 visual inspection of the structure found that armor stone had become dislodged or subsided at numerous areas along its entire length, exposing bare earth or the smaller engineers rock (6 to 12 inches in diameter) at steep grades. In response to the deteriorated condition of the armor, approximately 5,000 tons of stone (about 17%

The effects of rock revetment at Seadrift are difficult to quantify and vary due to site-specific conditions, but the response of beach processes and morphology may be described qualitatively. In general, the steep profile of the riprap, relative to the more gentle slope of a natural beach, increases wave reflection and results in lower beach elevations, especially during the winter when waves are more energetic. Lower beach elevation in turn increases the exposure to wave attack and accelerates the rate at which rocks along the toe of the riprap are dislodged. (PWA staff observed rocks dislodged from the recently repaired structure. See Figure 10.) The lower beach elevation and absence of backdunes probably extends the time required for the beach to recover to pre-storm conditions. If beach elevations lower substantially for prolonged periods of time, longshore transport of sand could diminish as fewer and fewer waves are able to ‘feel’ the bottom and move sand westward.
