INCLUSIVE ACCESS PLAN

Marin County Parks

Draft | November 2015

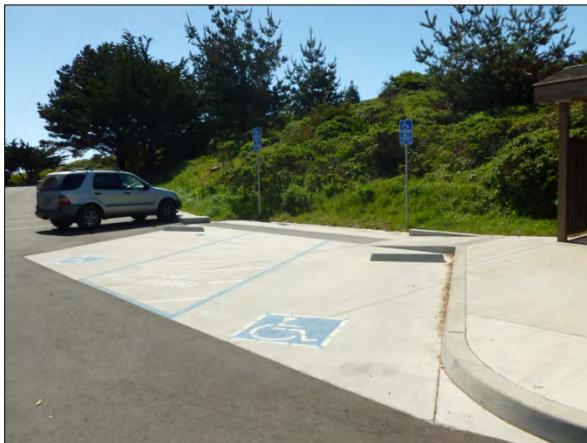
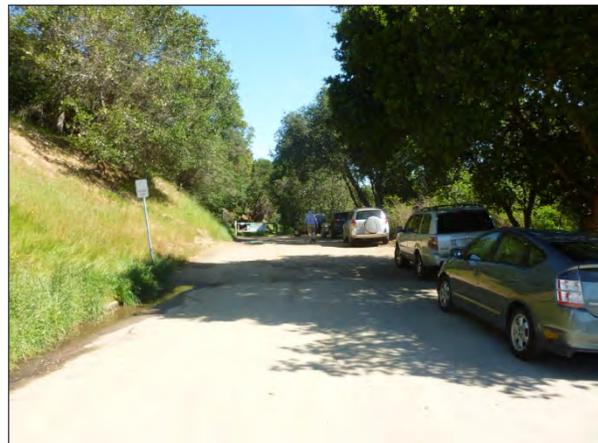
Images from left: Formal parking area with designated accessible spaces at Agate Beach County Park and informal street parking at Escalon Fire Road Trail.

Parking. The availability and condition of parking at the trailhead were noted. This included parking lots or on-street parking, presence of a designated accessible parking space, and the nature of the trailhead parking, such as a residential street or a public park area.

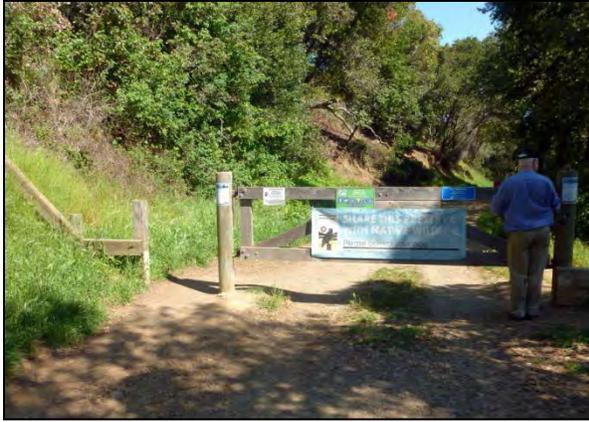
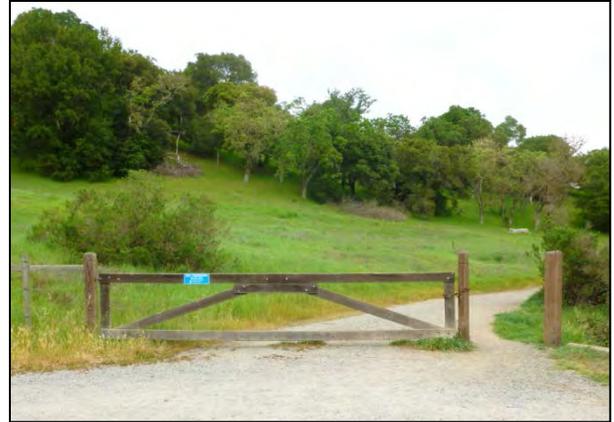
Gate/Entry. Many different gate and entry types were observed during the evaluations. Entries at trails intended to be accessible must be sufficiently wide to allow the passage of wheeled mobility devices, must be sufficiently level, and must have hardware operable by a person with limited dexterity. Gate features that limit access to certain user groups, like a zig-zag chicane, a step over, or cattle grates, should be limited in use and an alternative compliant gate provided.

Images from left: Pedestrian gate opening adjacent to maintenance vehicle access gates at Escalon Fire Road and Rush Creek Fire Road.

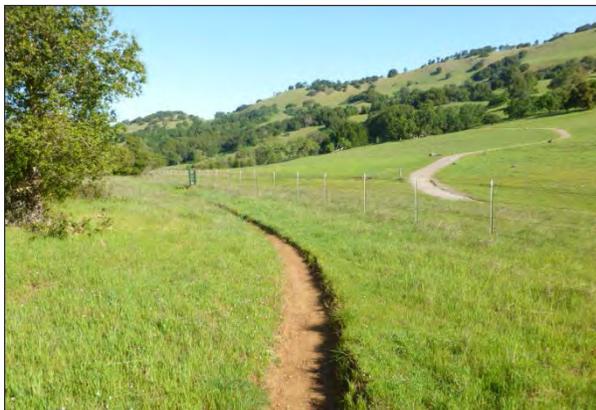
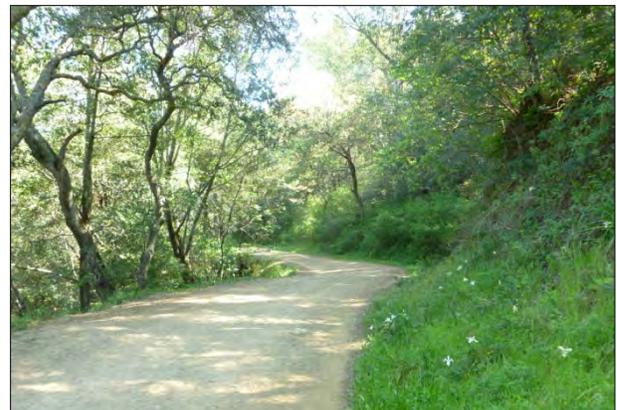
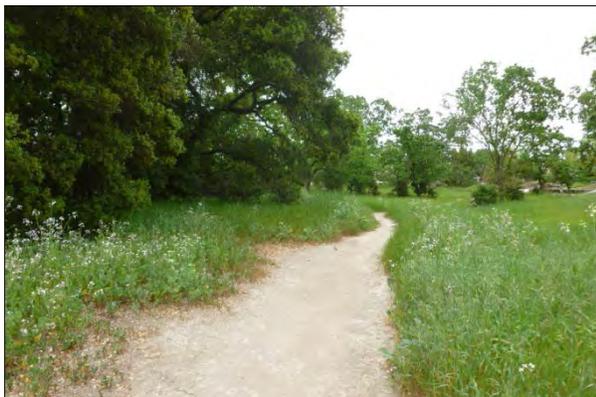
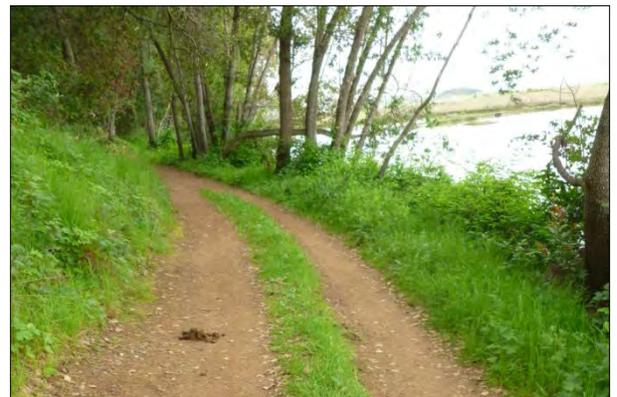
Trail Conditions. Trail width is indicative of how trail users interact with each other and whether adequate passing space is provided, such as when an equestrian and a person using a wheelchair must pass one another. Sight lines and speed of travel also affect user interactions.

Images top row from left: Narrow trail at Dwarf Oak Trail and wider alignment at Escalon Fire Road. Bottom row: A moderate width trail at Santa Margarita Island and split-level trail with grass median at Pinheiro Fire Road.

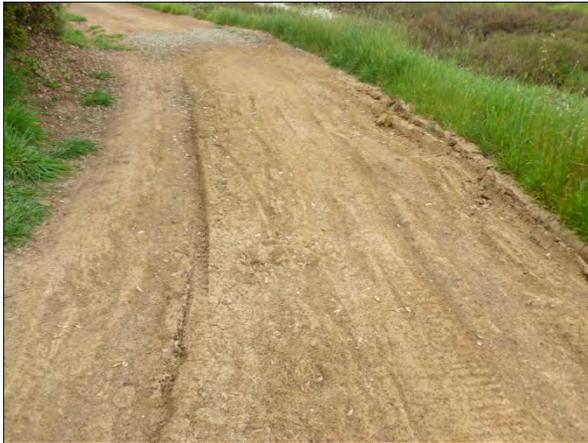
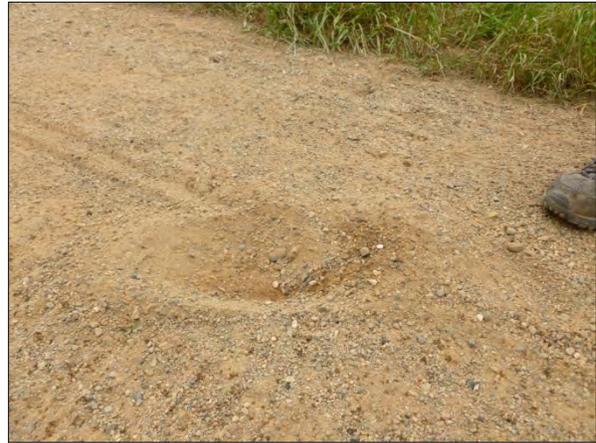
- Could a person ride a narrow-tired bicycle across the surface easily without making ruts? (The size of the bicycle tires is similar to large rear wheels of a wheelchair.)
- Could a folding stroller with small, narrow plastic wheels containing a 3-year-old be pushed easily across the surface without making ruts? (The size of a stroller's wheels are similar to the front wheels of a wheelchair.)

Images from left: Bike and equestrian tracks in dry and hardened trail surface and loose sandy material illustrate a trail surface that is not firm and stable, as described by the US Forest Service protocol for evaluating firmness and stability of trail surfaces. Both images are from Rush Creek Fire Road.

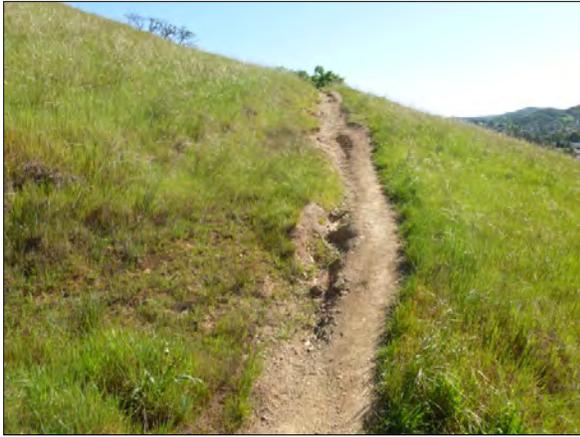
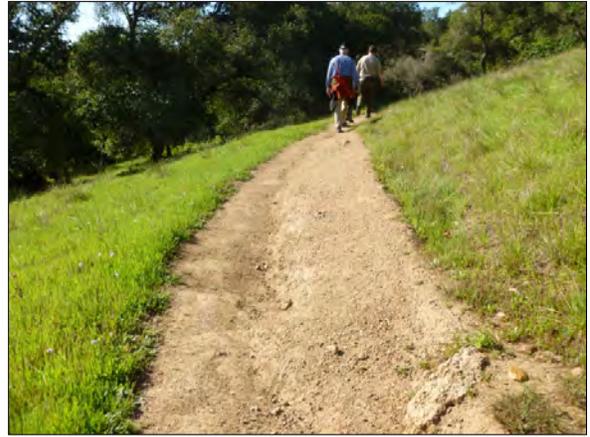
Slopes. Trail guidelines for accessibility identify maximum slopes allowed for specific distances between level resting intervals. Trails were evaluated to determine the running slope (the grade of the trail parallel with the direction of the path of travel) and cross slope (the grade of the trail perpendicular to the path of travel). Measurements were taken where either running or cross slopes exceeded what is identified in the guidelines as acceptable. An initial assessment of terrain constraints was noted for the potential to improve excessive slopes.

Images from left: Running slope with drainage channel parallel to the path of travel within the trail surface and cross slope running perpendicular to the path of travel. Both images are from Dwarf Oak Trail.

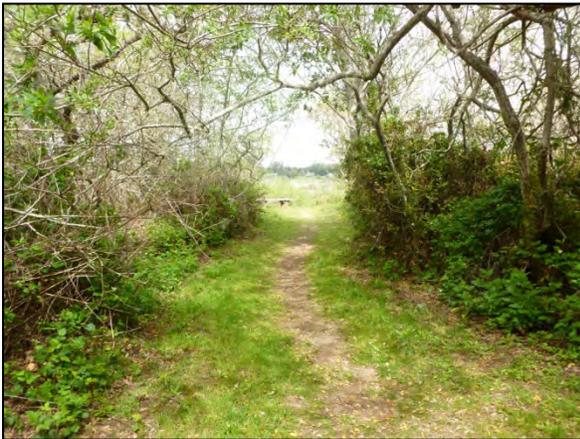
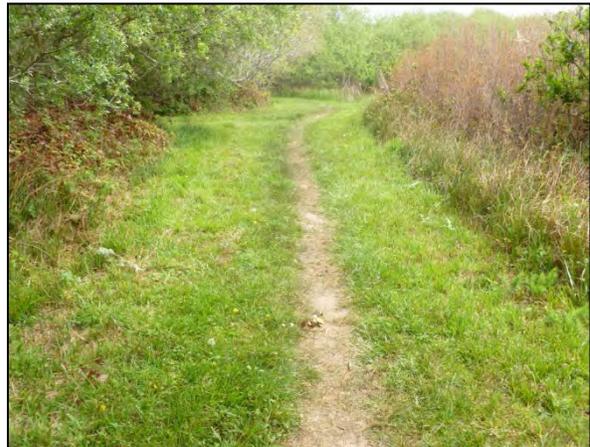
Overgrown vegetation may limit the accessibility of a trail and should be regularly cleared when it will limit the usable width or height of the trail. Overhanging branches can cause injury to people with visual disabilities who may not be able to detect the impending hazard.

Images from left: Overgrown branches and grass at Whitehouse Pool reduce the clear height and width of the trail.

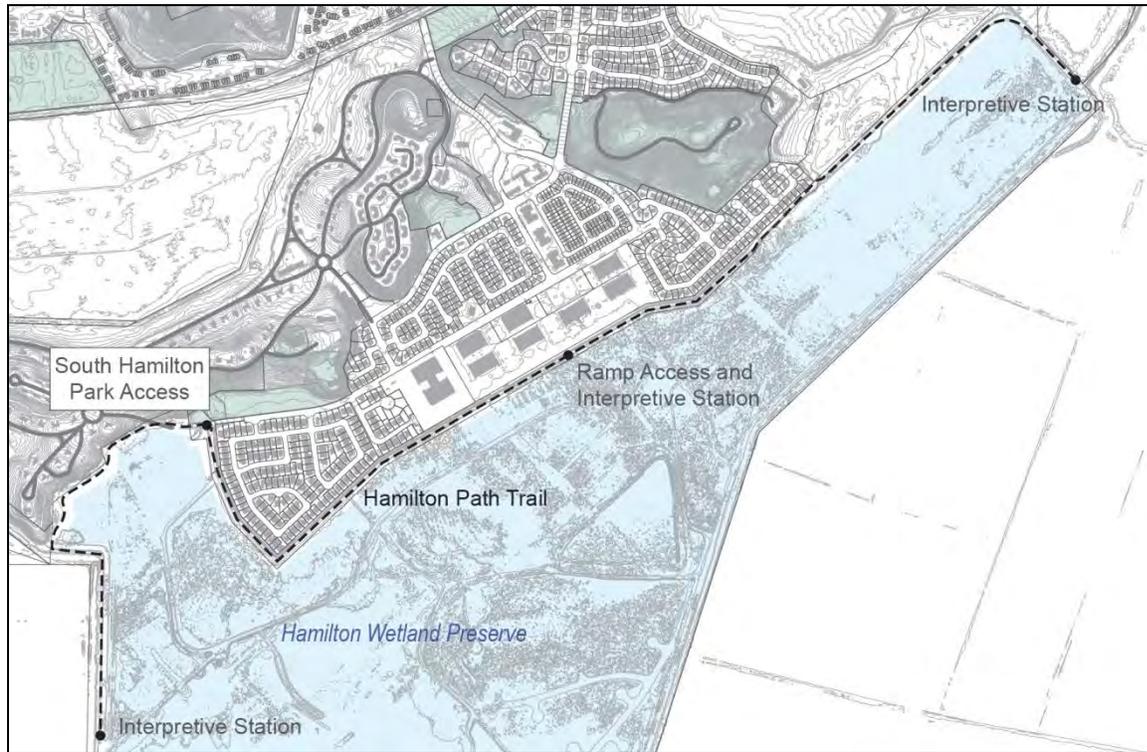
Hamilton Path

Hamilton Trail is a 14 foot wide newly constructed decomposed granite trail running along a levee adjacent to seasonal wetlands and the newly constructed Hamilton Field Wetland Restoration area. It provides views of Mount Burdell, Mount Diablo, and Mount Tamalpais from different vista points. The trail has historical significance as a former airfield with hangars and air tower remaining along the central section. The trail is exposed to sun and wind; minimal shade is available and only at the south end. Benches and interpretive signage stations are provided along the length of the trail. Some benches are not located on an accessible surface.

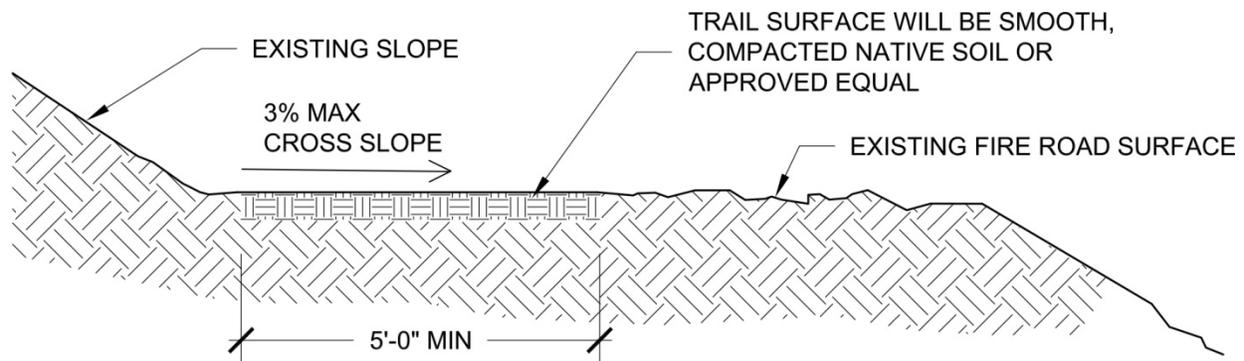
Improved Surface on Uphill Side of Fire Road

Where fire roads have been identified as a Destination-Oriented or Improved Access Trail, it may be necessary to provide surface improvements along the alignment. It is not necessary that the improvements encompass the entire width of the fire road, but can be limited to a trail wide section.

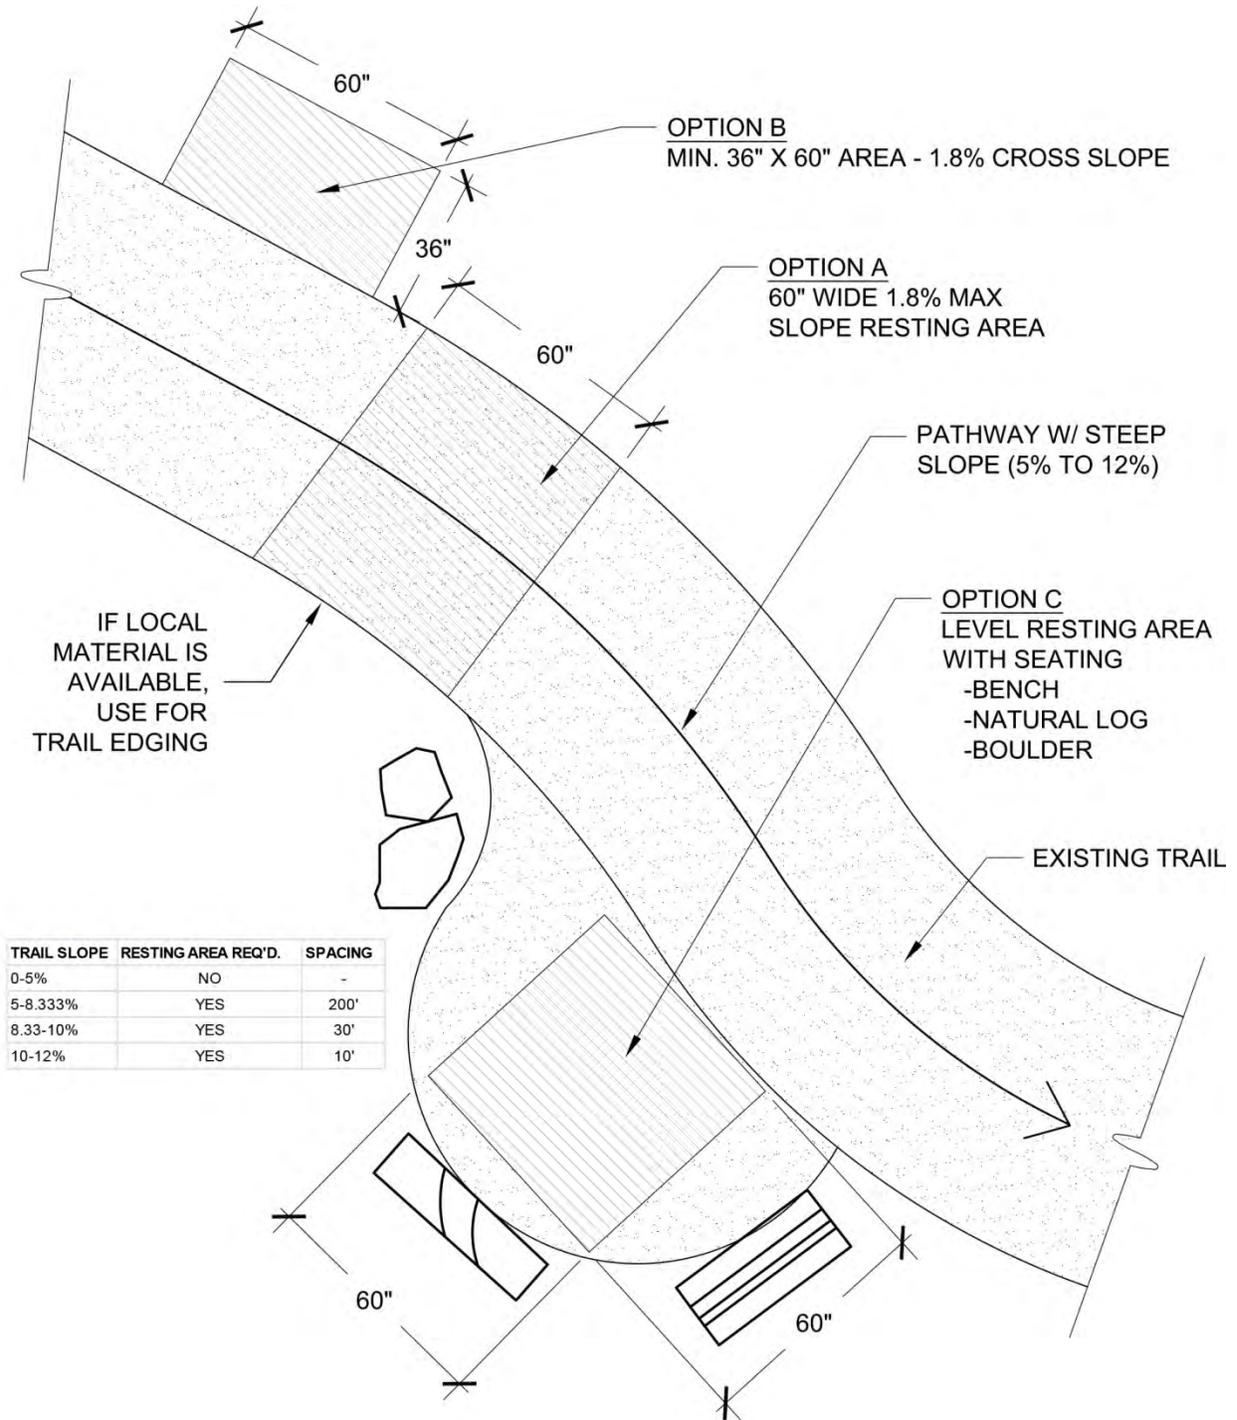
Resting Interval Location Options

Turning Space. Where resting intervals are provided adjacent to the trail tread, a turning space shall be provided. Vertical alignment between the trail tread, turning space, and resting interval shall be nominally planar. (ABA 1017.8.4)

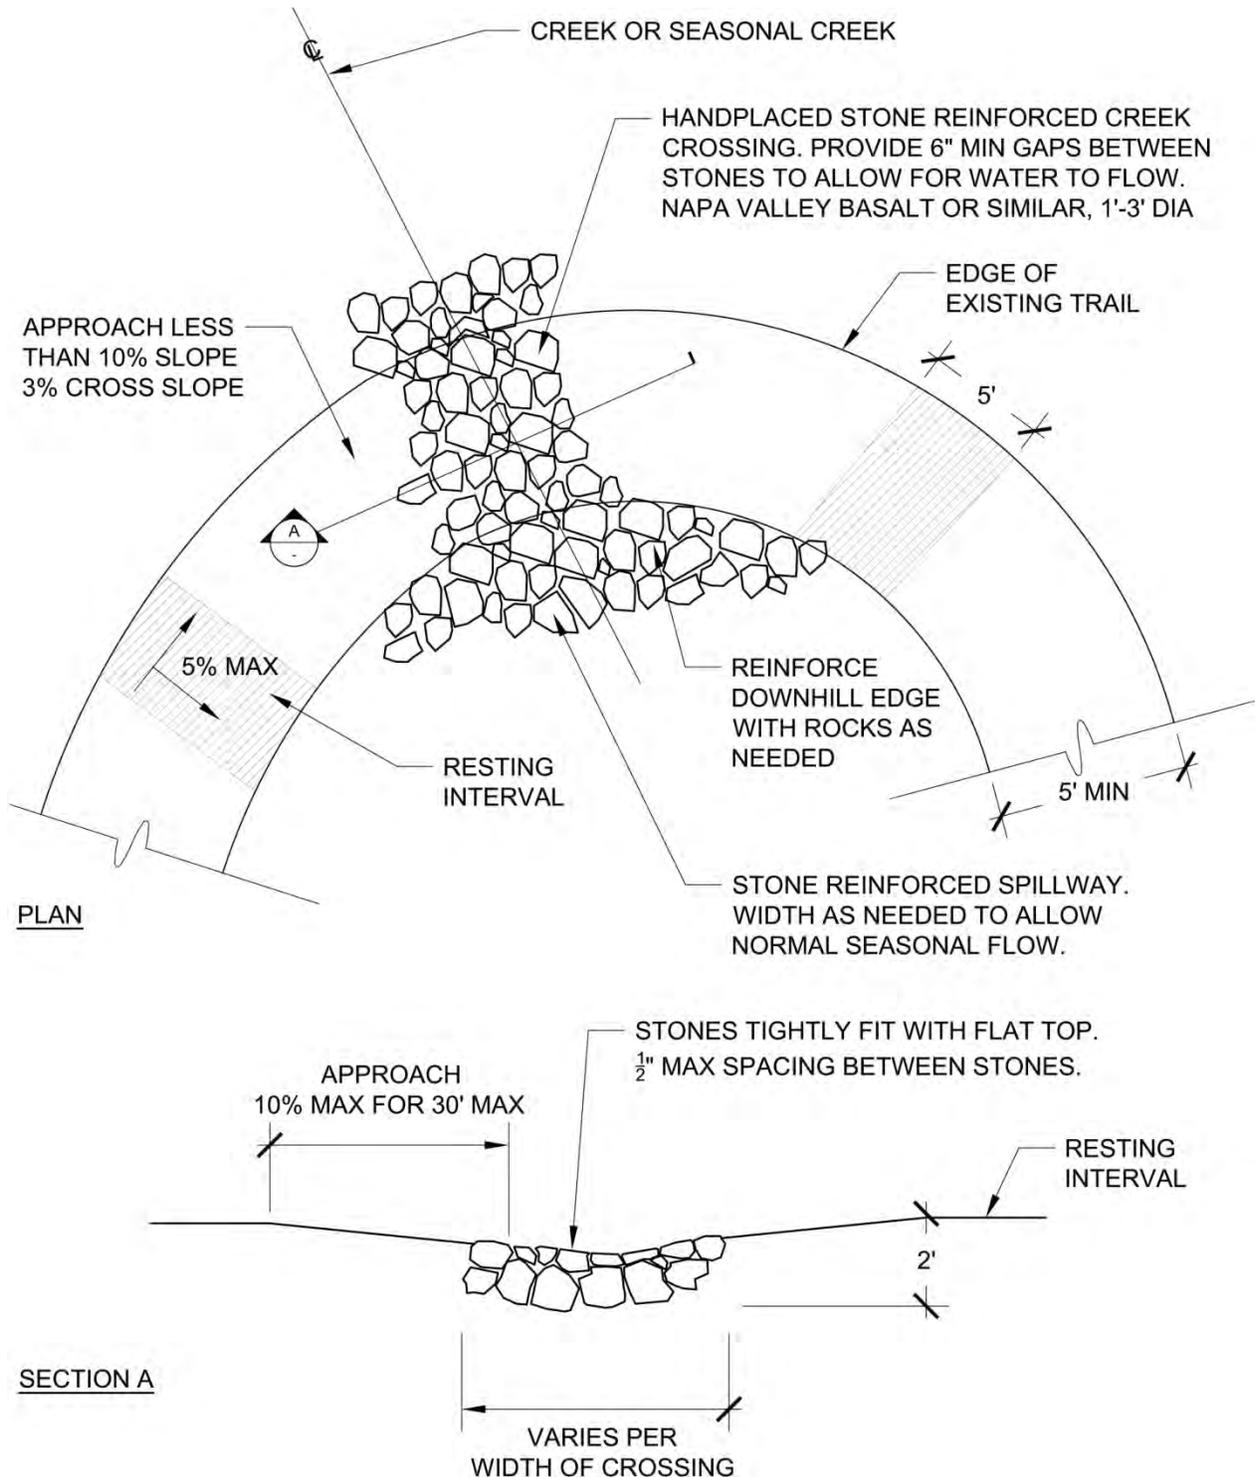
Armored crossings are necessary where a waterway runs perpendicular to the trail alignment and may cause erosion. Modified crossings at a waterway of any kind will require permits from regulatory agencies. The final design specifications will be subject to review and approval by these agencies and may require modifications to the detail below.

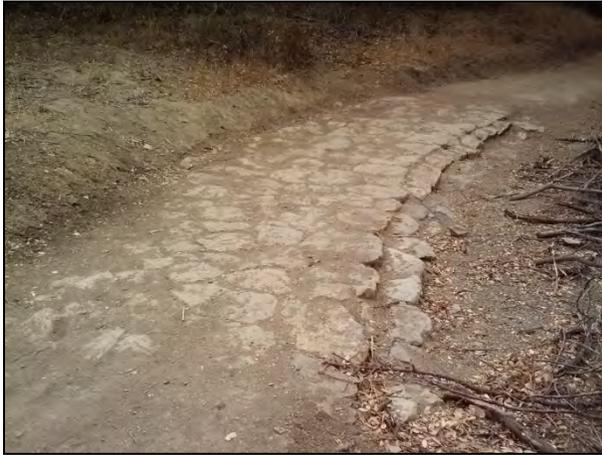
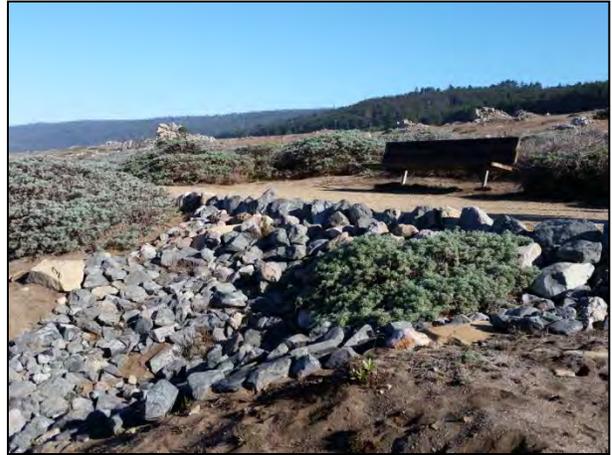
Images from left: Armored crossing of stone with minimal openings at the surface and a trail section with compacted trail surface extending across top of armored crossing.

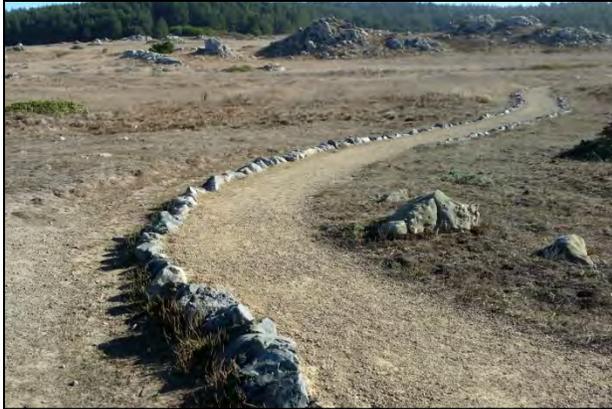
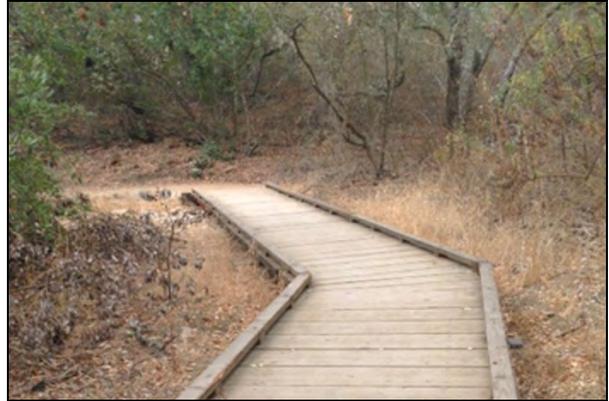
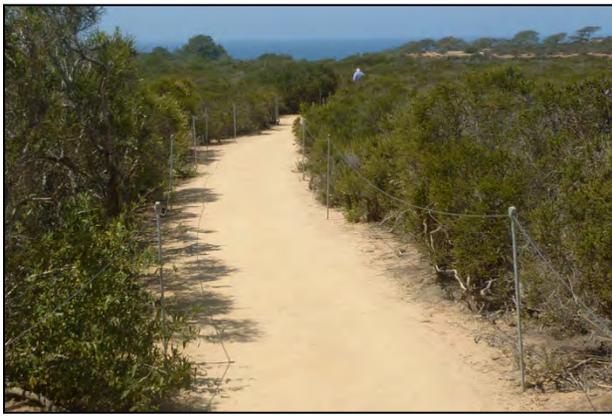
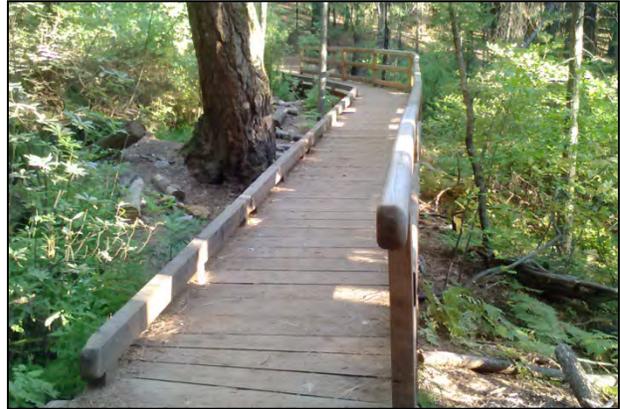
- Guard rails shall not be less than 42 inches high measured vertically from the trail surface when there is a drop off of 30" or greater. (CBC 1013.3)
- Raised rock edging or wooden wheel guides shall rise 6 inches minimum above trail surface and provide a continuous and uninterrupted barrier along the section receiving the edge protection. Any openings between the trail surface and the edging shall not be greater than 4 inches. (CBC 11B-303.5)
- Rope or cable guides are not addressed in regulatory standards however a height of 34 to 38 inches above the trail surface is consistent with other standards and is the height recommended by this plan.

Images top row from left: Rock trail edging to define and hold trail edge and wooden wheel guide along boardwalk. Bottom row: Cable guide along the trail edge and a wooden guardrail section where there is a significant drop off from boardwalk surface to adjacent natural surface.

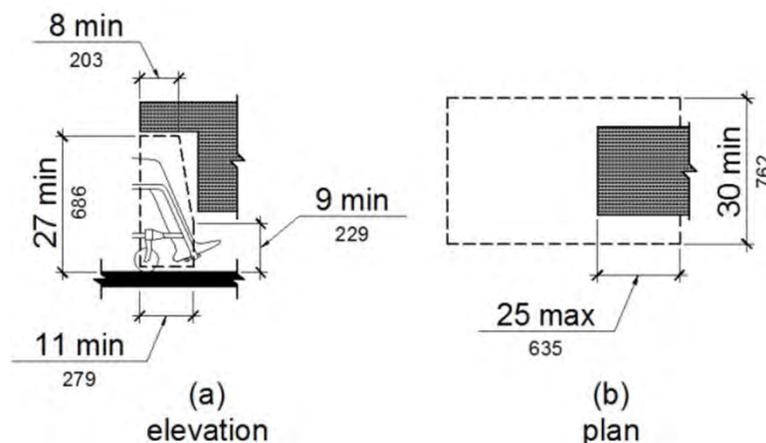
Knee and Toe Clearance at Drinking Fountain

A 30 by 48 inch minimum clear, level space must be provided in front of the fountain for front approach. (CBC 11B-305; ADA 305)

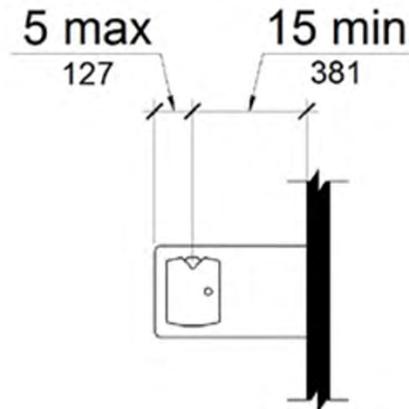
Drinking Fountain Clearances

The flow of water must be approximately parallel to the front of the fountain and at least 4 inch high and located no more than 5 inches from the front of the drinking fountain. The bubbler is 15 inches minimum from a vertical support or wall if present. (CBC 11B-602.6)

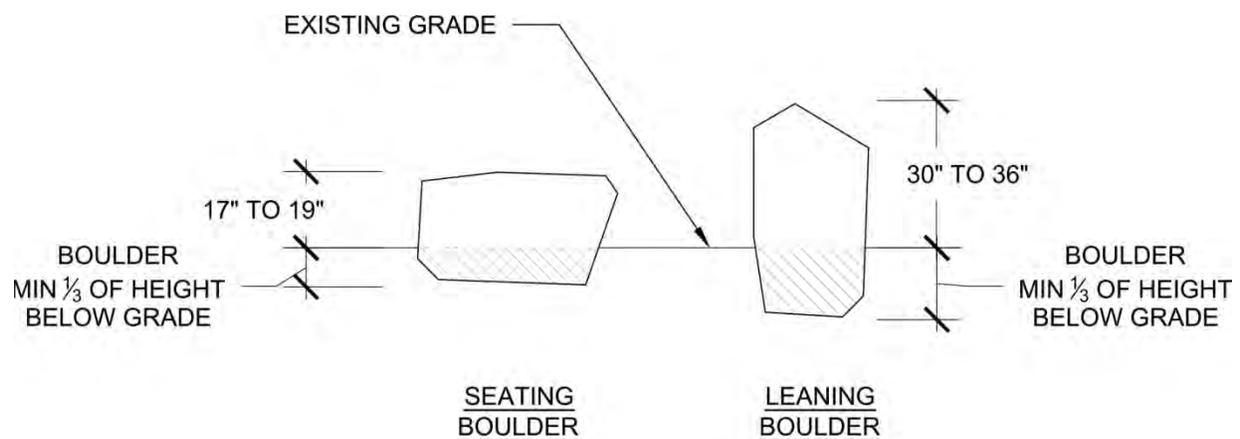
Informal Boulder Seating

Where formalized benches are deemed not appropriate to the trail or site, alternative seating models may be used. One such example would be boulders serving as informal seating or leaning stations. When using boulders and informal seating, ensure selected boulders are smooth and free from jagged edges.

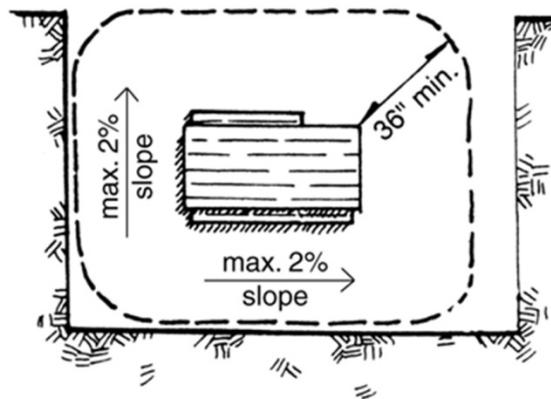
Clear Ground Space at Picnic Table

- One full unobstructed side of the clear ground space around an accessible picnic table must adjoin or overlap an outdoor recreation access route or a trail, as applicable, or another clear ground space. (ABA-AGODA 1011.2.1)
- The surface of the clear ground space must be firm and stable. (ABA-AGODA 1011.2.2)
- The slope of the clear ground space surface must not be steeper than 1:48 (2%) in any direction. Where the surface is other than asphalt, concrete, or boards, slopes not steeper than 1:20 (5%) shall be permitted when necessary for drainage (ABA-AGODA 1011.2.3)
- Openings in the ground surface such as grates, spaces in decks, etc. may not be greater than ½ inch. (ABA-AGODA 1011.2.4)
- A clear floor or ground surface at least 36 inches wide must be provided at the usable portion of the table measured from the back edge of the benches. (ABA-AGODA 1011.2.1)

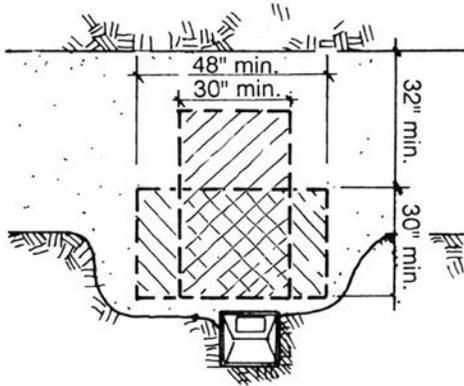
Clear Ground Space at Trash Receptacle (Plan)

Where bins are provided for envelopes, waste paper, or other purposes, at least one must located along an accessible route. (CBC 11B-206.2; ADA 206.2)

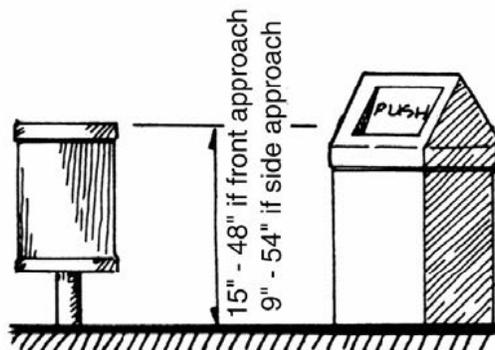
Operating mechanism is operable by a single effort with no grasping, pinching, or wrist movement. Operating effort does not exceed 5 lbs. 309.4 Exemption: Hinged lids and controls designed for large animal exclusion and dumpster type trash and recycling receptacles (ABA-AGODA 1011.3)

Operating mechanism or openings are located within 15 to 48 inches of the ground. (ABA-AGODA 1011.3)

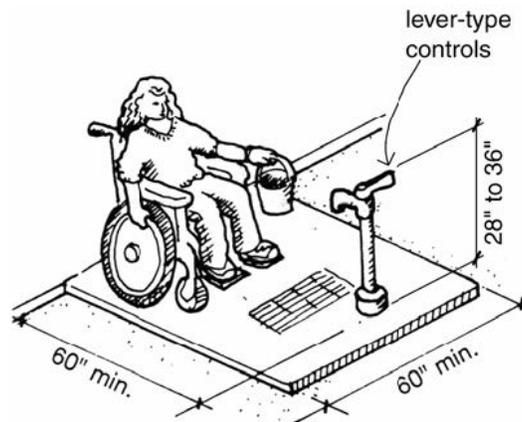
Water Spigots/ Hand Pumps

A clear floor or ground space that is at least 48 by 72 inches must be provided at an accessible water spigot, with the long side of the space adjoining or overlapping an accessible route. The clear floor space must be oriented to that the water spigot is between 11 and 12 inches from the rear center of the long side of the space. (ABA-AGODA 1011.2.1)

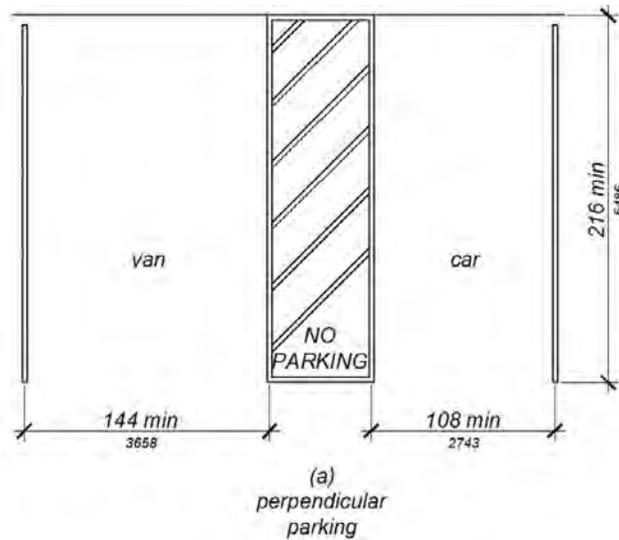
Accessible stall width must be at least 9 feet measured centerline to centerline of the pavement markings. If there is only one accessible parking space, include the entire line width in the measurement. Stall length must be at least 18 feet. The van accessible space must be 12 feet wide if access aisle is only 60 inches wide. (CBC 11B-502.2)
