Access and Discovery Trails

Rush Creek Fire Road
Bugeia Lane, Novato

Inclusive Access Plan
Access and Discovery Trails

Rush Creek Fire Road

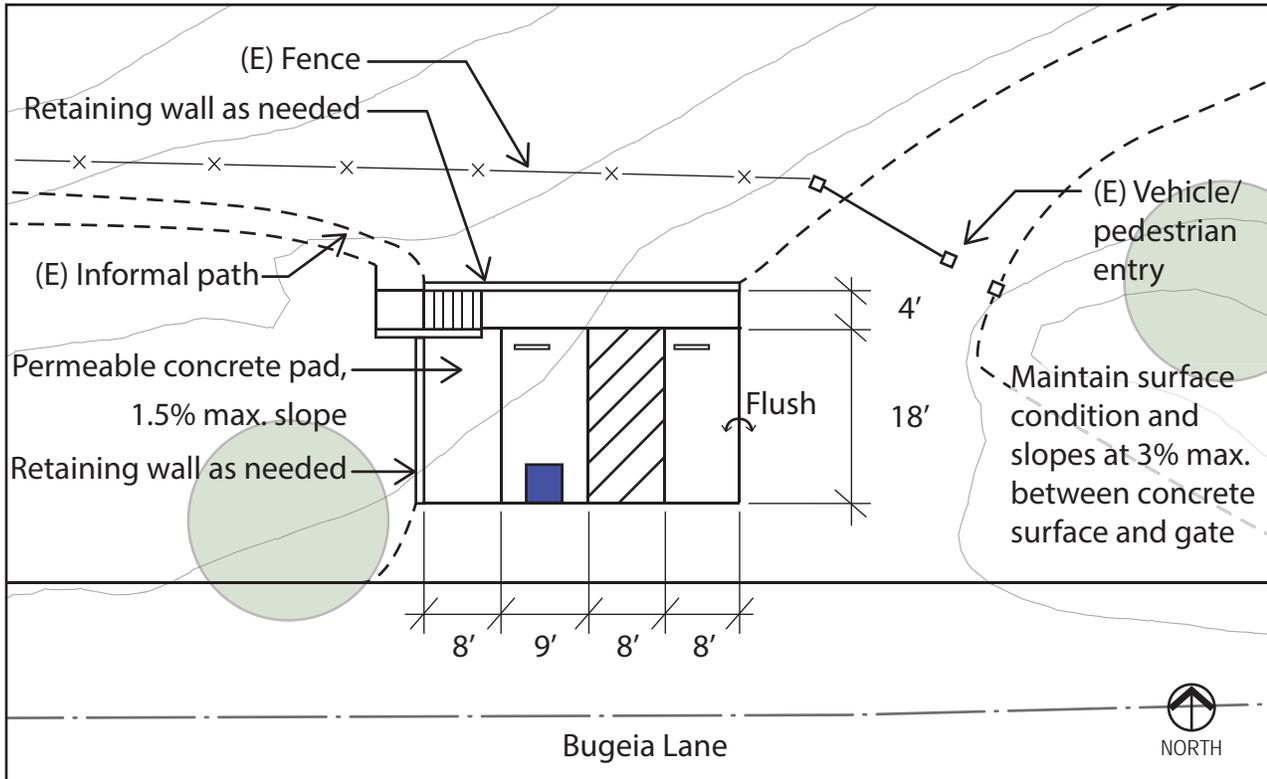
1

An informal gravel parking area with sections of significant slope is available on Bugeia Lane at the entrance gate. Curb side parking in front of residences is located along Saddle Wood Drive with a pedestrian connection to the trail/fire road.

Bugeia Lane Accessible Parking

Proposed Improvement: Provide an accessible parking area with a single accessible stall including access aisle at the Bugeia entrance and two paved parking spaces not designated for accessibility. Grading and construction of retaining wall will be required to create a level parking area.

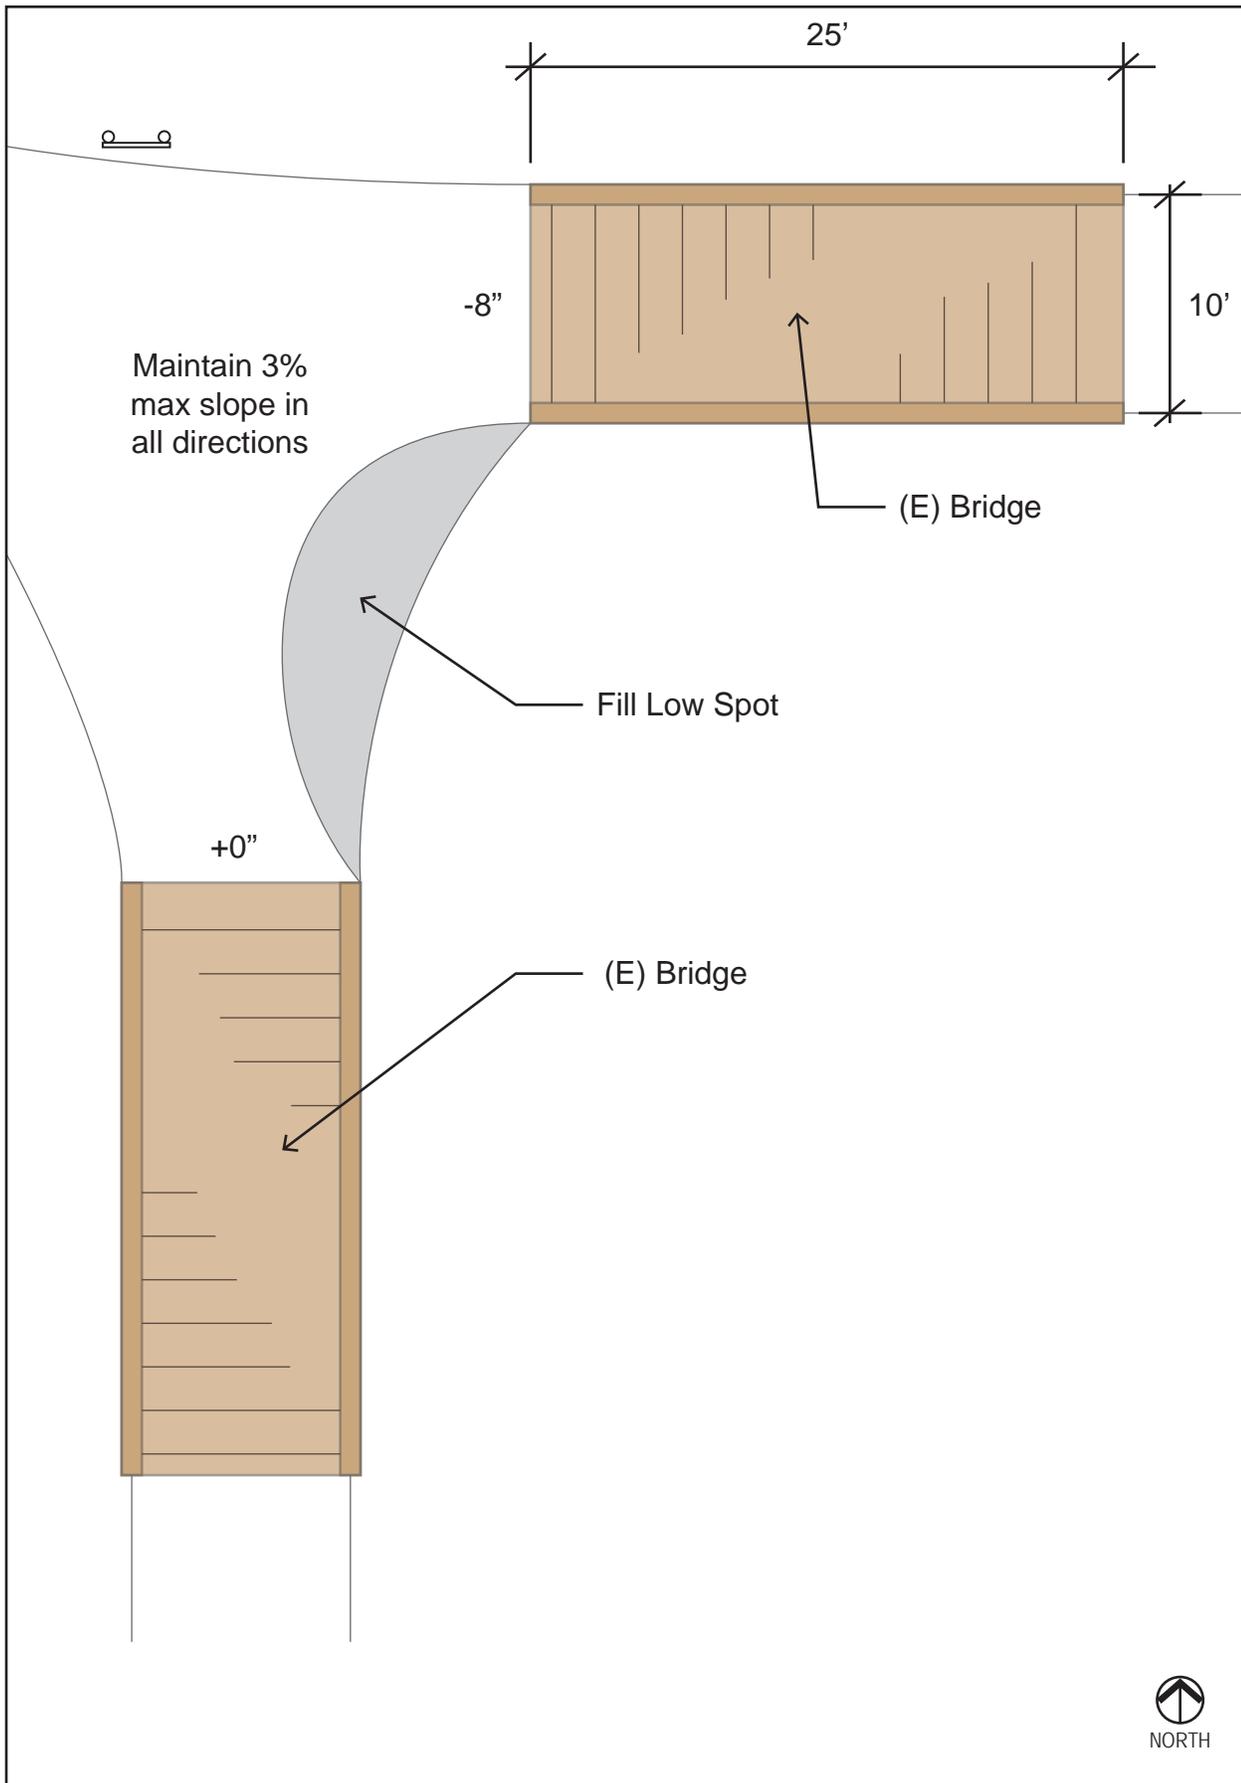
2

The trail has poor drainage with evidence of standing water. There is a possibility of seasonal closures during high water periods. An assessment of the existing trail surface materials suitability to be properly compacted to meet access requirement may be needed. Existing wood boards on the bridge surface have gaps that exceed the allowable ½" gap. Replacement of the boards with properly spacing is recommended.

Regrading at Wood Bridges
Scale: 1/8" = 1'-0"

Proposed Improvement: Remove sections of loose surface materials and replace with firm and stable compacted surfacing. Install edge protection at the steep slope immediately south of the pedestrian bridges. Modify the trail section between the bridges to provide a more level connection. Provide resting intervals at several locations where the trail has steeper sections. Consider providing a resting place with a bench at a shady spot along the trail alignment.

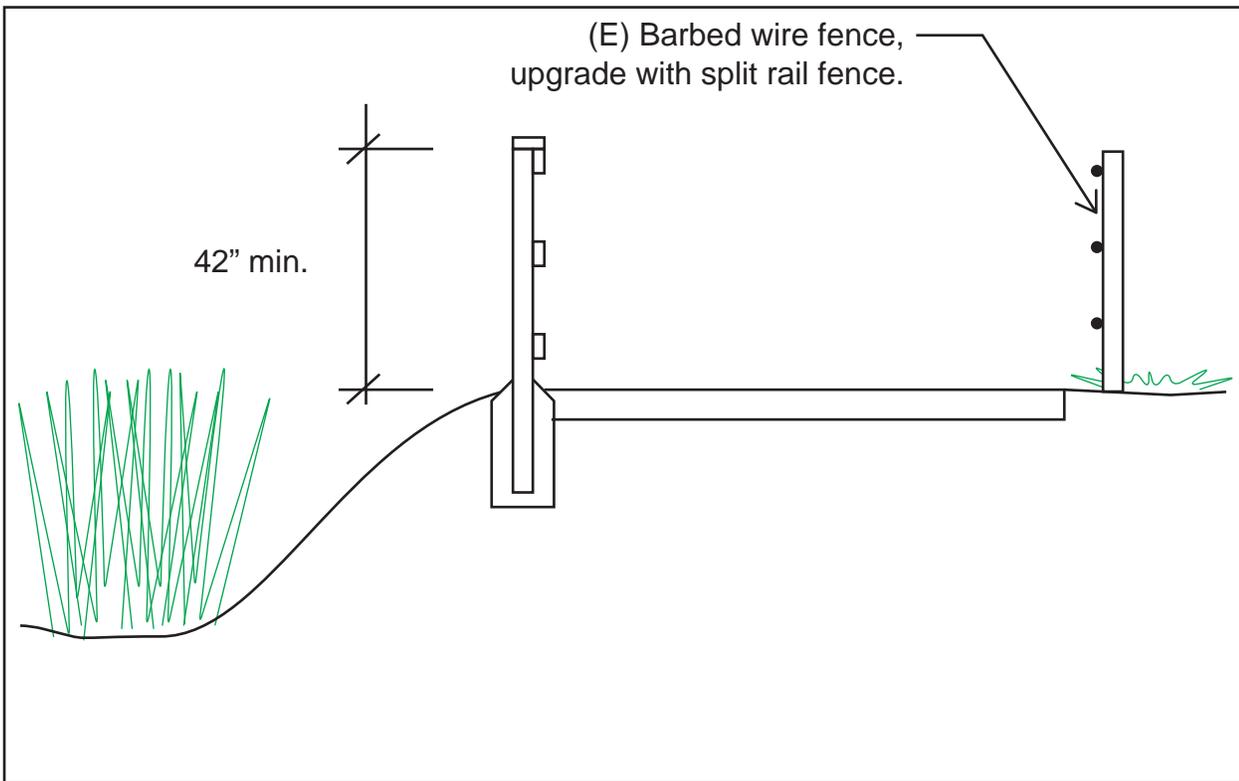
4 Edge Protection
Scale: 1/4" = 1'-0"

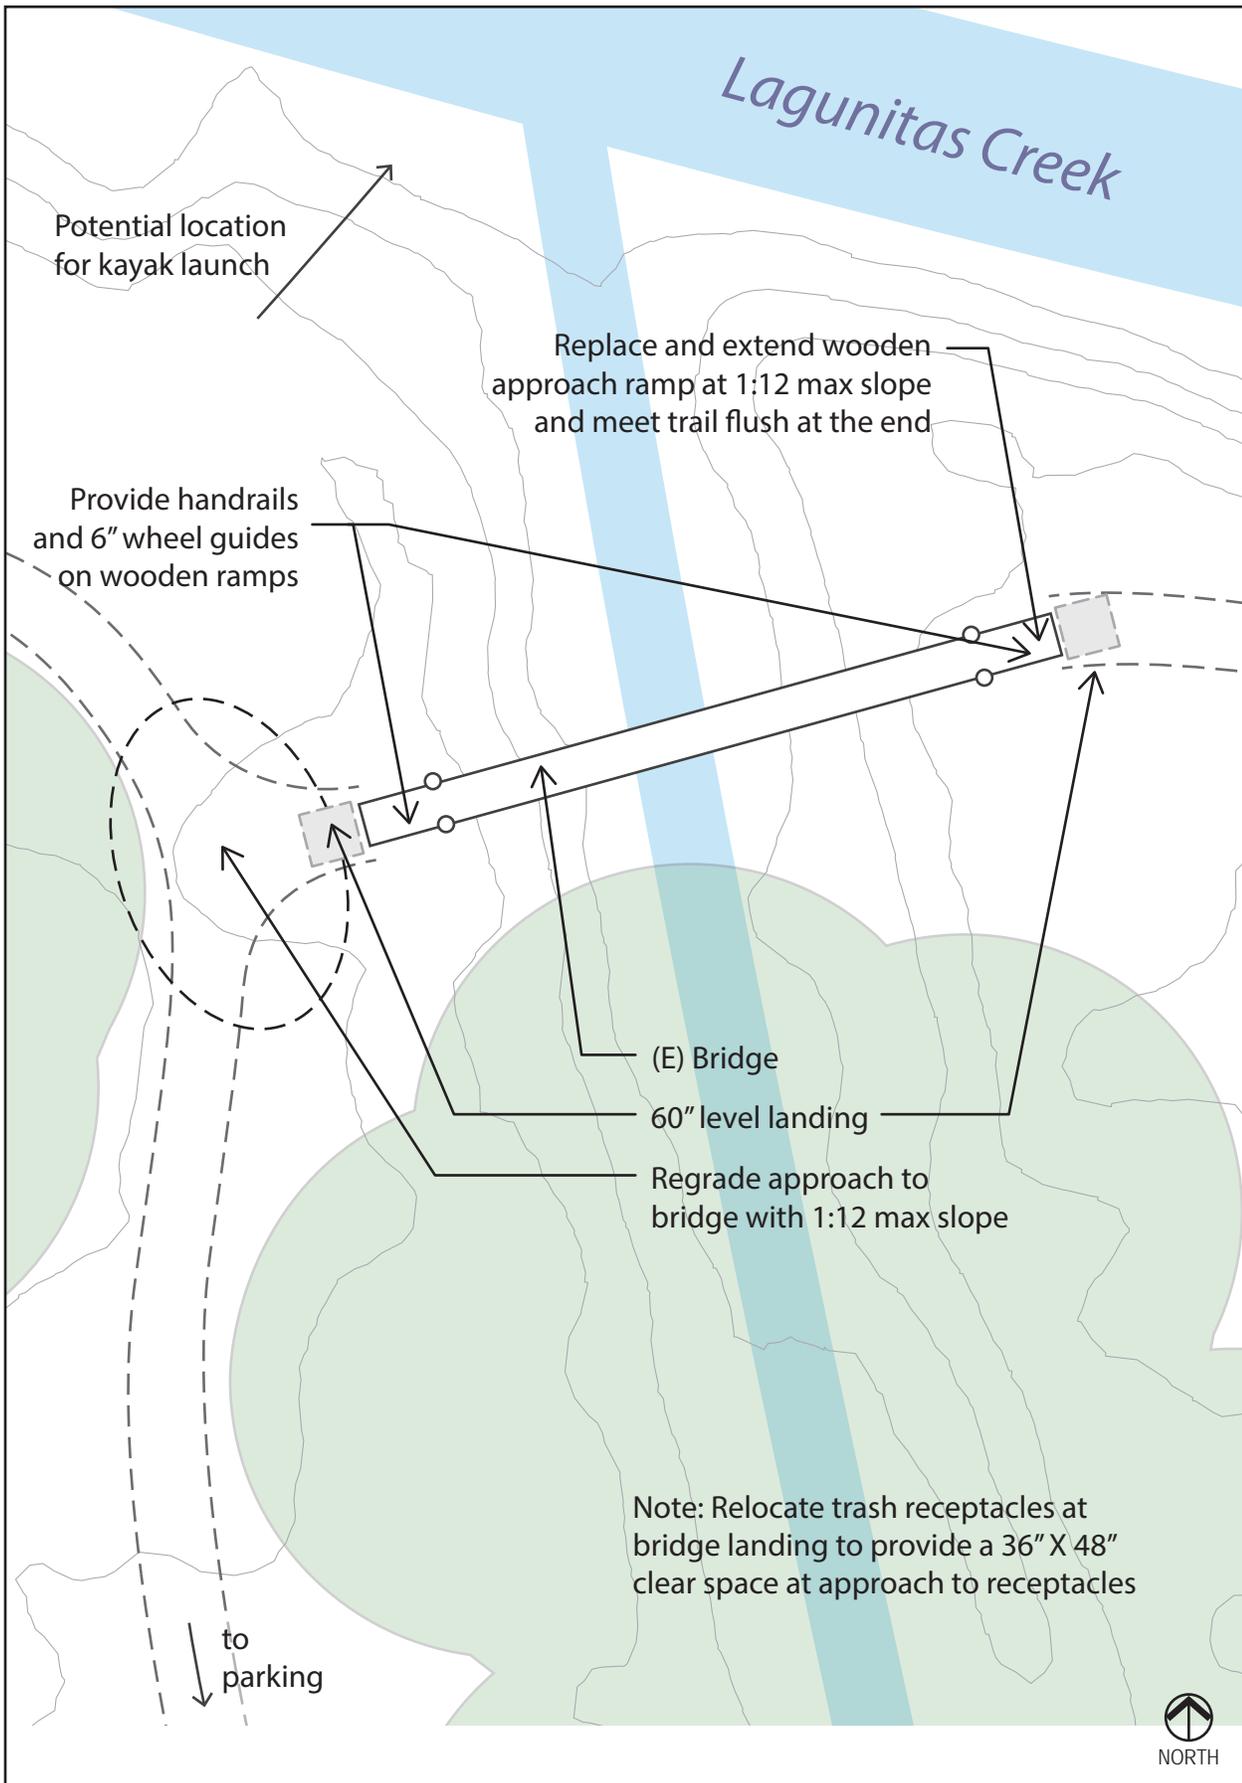
2

The trail has two timber bridges. The bridge adjacent to Sir Francis Drake Blvd on the east side of the site is 60 inches wide. A 14% slope and 3 inch change in level were observed at the transition plate. The second bridge crossing the inlet between the two trail sections is 48 inches wide. The wood transition on the east side of the bridge has a slope of 12% for 14 linear feet and up to 24 inch changes in level on either side with no edge protection. The transition on the west side includes a 14 foot long timber section with a slope up to 6% connected to an earthen ramp with a slope of 9% to 11% for 15 linear feet.

Regrading at Bridge
Scale: 1" = 20'-0"

Proposed Improvement: Improvements to the pedestrian bridge near the parking area include modifying the slope of the approach ramp, installing safety railing to the wooden bridge ramp. Trail improvements include widening the trail tread and providing accessible trail surfacing to selected benches at the bank of the creek. A section of boardwalk is also recommended to address reduced trail width along the riparian clearing as noted on the diagram.
